Mechanical Overview of system components involved in this inspection. The below image is representative of the 4 socket x3850X6. The issue described could also occur in the 8 way x3950X6, in either shuttle bay:

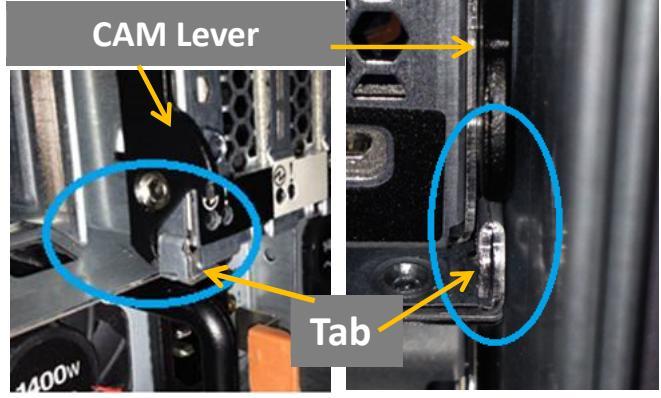
• The Standard I/O Book CAM levers should be behind the Shuttle's Tab

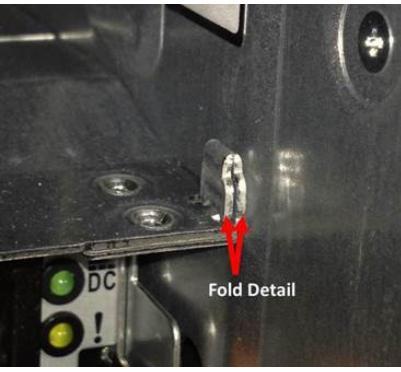
• Both the left and right Shuttle Tabs should have a folded metal detail, giving the tab a double thickness:

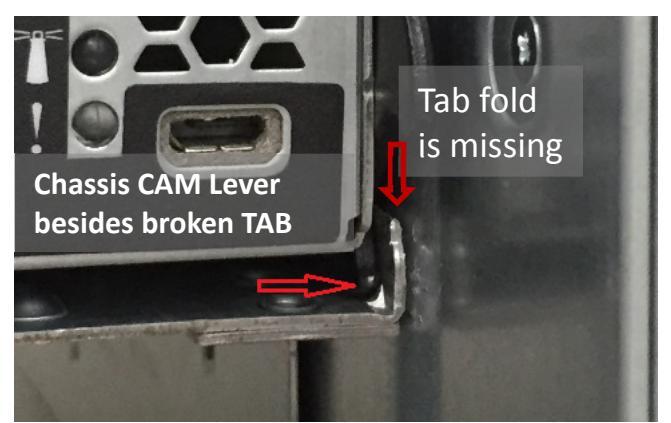
• A broken Tab will not have a folded detail (there will be a single thickness of metal). The CAM lever might be 'besides' the single thickness of metal.

- If a broken Tab is observed, then the Shuttle needs to be replaced.
- Inspect the seating of the Standard I/O Book into Shuttle. The Standard I/O Book should seat evenly into the Shuttle, slightly underneath the top lip.

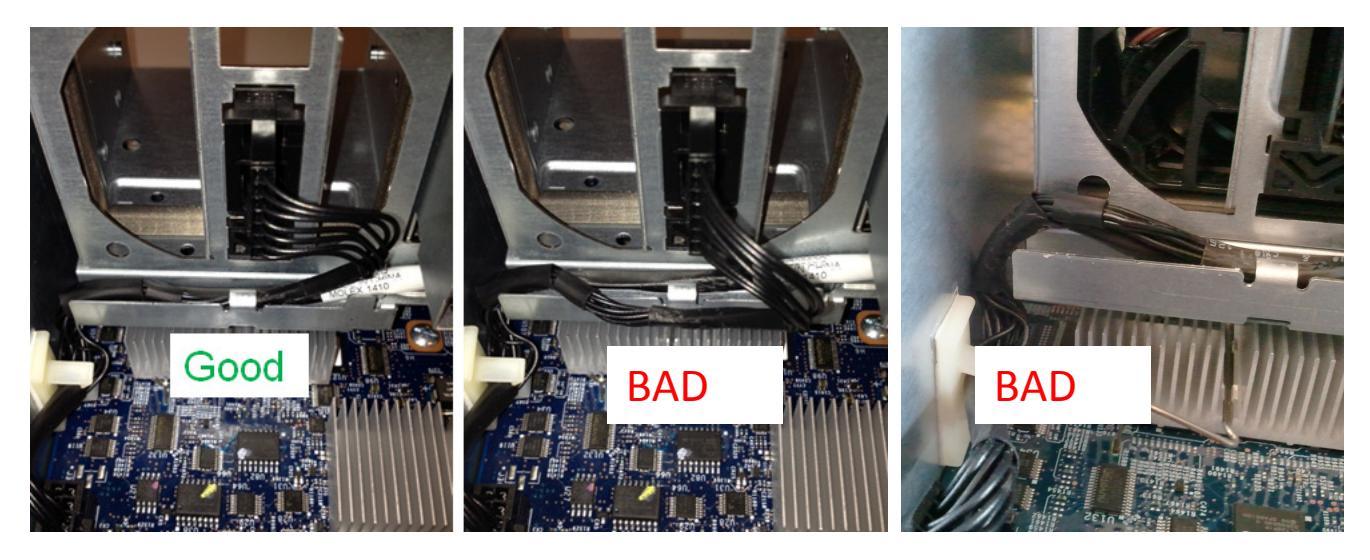
- If the Standard I/O Book does not appear to be seated properly (regardless of Tab condition), remove the Standard I/O Book for inspection.
- With the Standard I/O Book Removed, inspect Fan cable wires (under the Air Baffle) and make sure they are tucked into the channel, under the retaining hook.

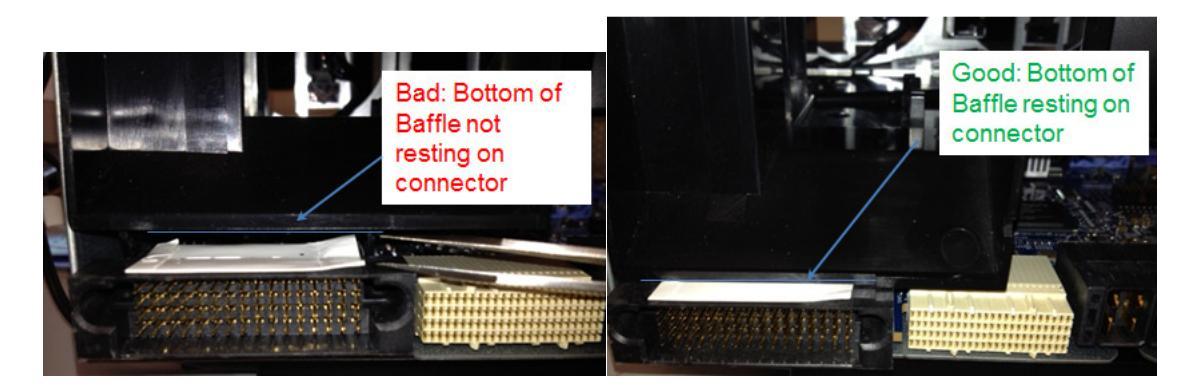
• If the wire assembly is not within the channel, then the Air Baffle might not seat properly:

- If the Air Baffle fails to seat properly, the Standard I/O Book will not seat within the Shuttle properly, causing excessive force when closing the CAM levers.
- Inspect the Midplane connector/pins and the Standard I/O Book connectors/pins for damage. If any damage is suspected, replace the affected parts.
- Insertion of the Standard I/O Book should be done with CAM levers in the open position.
