**Troubleshooting Memory on IBM
System x® and BladeCenter® Servers**
Using Intel Xeon 5500 Series Processors

*Nathan C. Skalsky, Sumanta Bahali
IBM Systems and Technology Group*

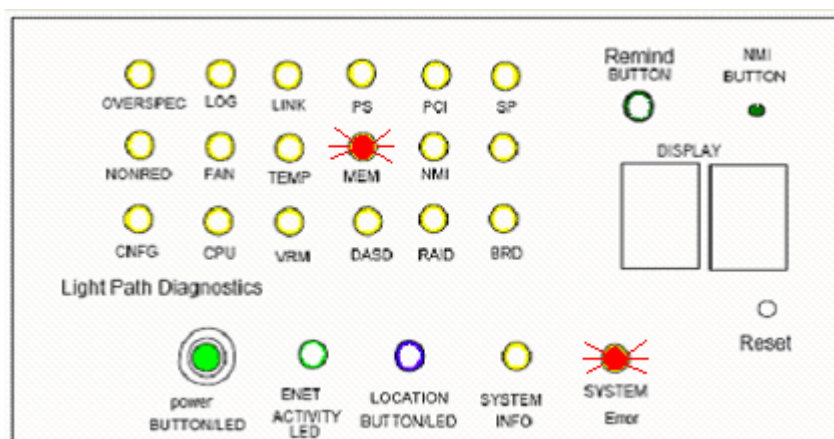
Figure 1: Light path diagnostics panel with the lit MEM and system-error LEDs

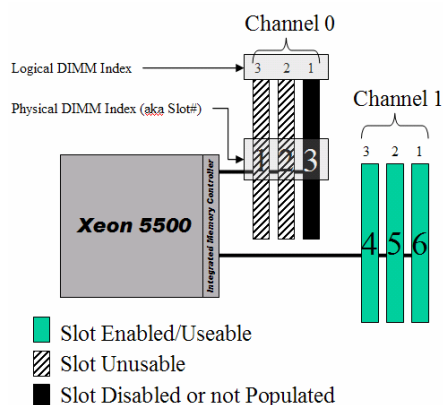
Example 1 – DIMM connector 3 disabled: If the first DIMM connector in a channel (physical connector 3 in the diagram) is disabled (because of a POST memory test failure or runtime double-bit error) or is not populated, the remaining two DIMM connectors (physical connectors 1 and 2) in the channel are inactive or unusable.

- If the DIMM in connector 3 failed as in Example 1, you can move the DIMM from connector 1 to connector 3 to enable the server to run with the remaining two good DIMMs instead of losing the use of the entire channel.

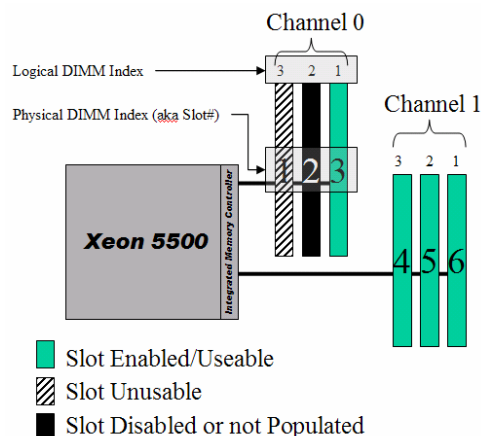
Example 2 – DIMM connector 2 disabled: If the second DIMM connector in a channel is disabled (because of a POST memory test failure or runtime double-bit error) or is not populated, physical connector 1 is disabled or unusable. The first DIMM connector in the channel (physical connector 3 in the diagram) is populated and enabled.

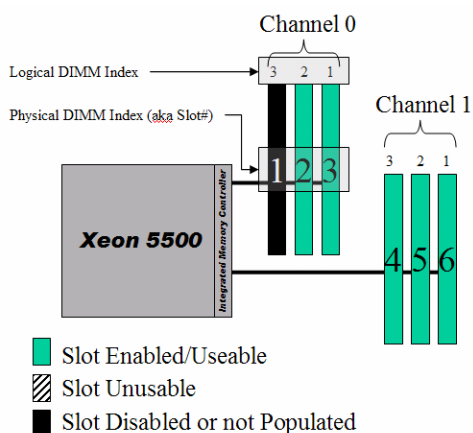
Example 3 – DIMM connector 1 disabled: If the third DIMM connector in a channel (physical connector 1 in the diagram) is disabled (because of a POST memory test failure or runtime double-bit error) or is not populated, only that connector is disabled or unusable. The first and second DIMM connectors in the channel (physical connectors 2 and 3) are still populated and enabled.

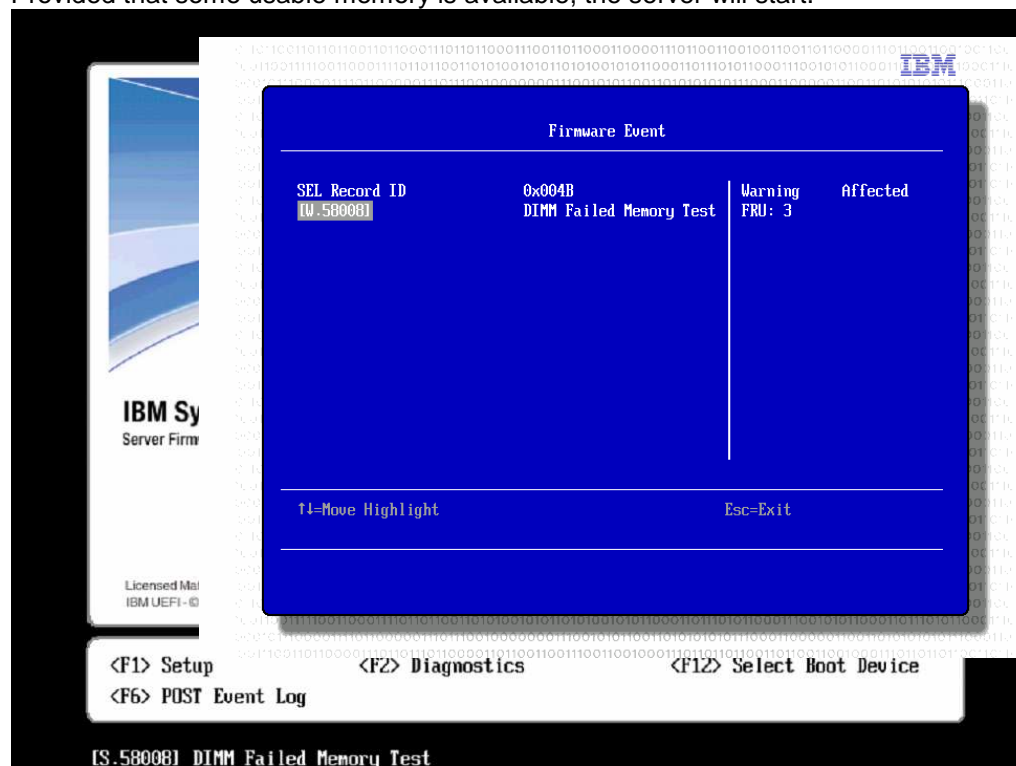
Screenshot of 'SplashScreen' w/ Memory Test Failure Message & F6 Post Event Viewer

- **Operational impact:** The DIMM connector that contains a DIMM that failed a memory test is disabled, and server will continue to start if other DIMMS are installed and pass the memory test.
- **Indications at the time of the failure:**
 - The system-error LED, MEM LED, and CFG LED (in a server with a light path diagnostics panel) are lit.
 - A Memory Device Configuration Error platform event is logged in the system-event log.
- **Possible root causes:**
 - Defective DIMM, ECC errors
 - Damaged DIMM connector
 - Damaged processor or socket
- **Suggested corrective action:** Replace the defective DIMM as indicated by the logs, the DIMM Planar Details form in the Setup utility, and light path diagnostics. Follow the memory problem determination procedures to isolate a potentially failing part.
