Power775
Drive Carrier Service Procedure
Last Modified 9/28/2011

Power775 Drive Carrier Service Procedure
PN: 41U8186, EC N44172

2.4 Drive Carrier Description

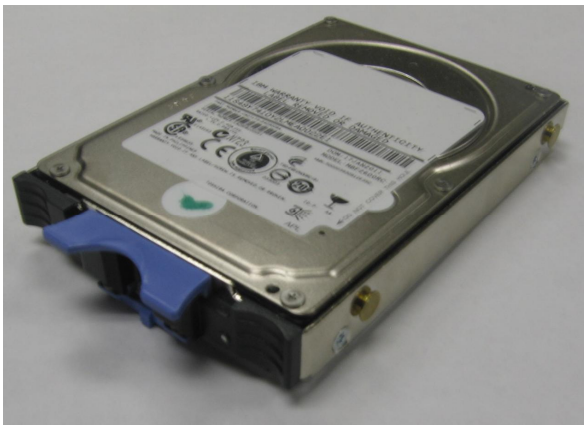
Figure 1 Hard Drive Assembly Photo

- a. A 2.5” Small Form Factor (SFF) Serial Attached SCSI (SAS) Hard Drive Assembly
This will be referred to as “hard drive”. See Figures 1 & 3.
- b. A 2.5” SFF SAS Solid State Drive (SSD) Assembly
This will be referred to as “SSD”. See Figures 2 & 4.

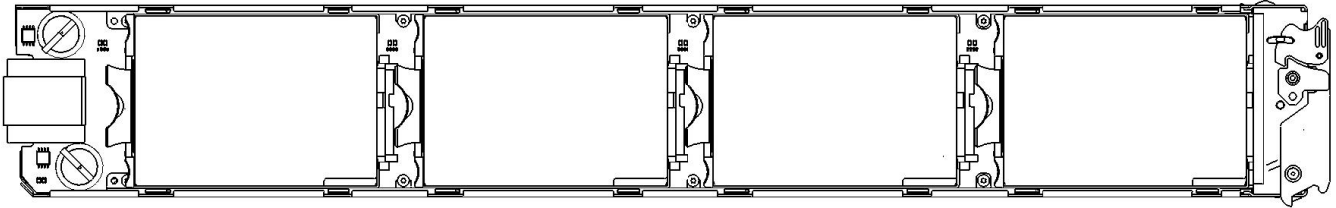
Figure 5 Drive Carrier Drawing

The Drive Carrier is used to hold up to four Drives located (Figures 5,6 and 7).
There are 96 Drive Carriers in the Disk Enclosure (DE) (see Figures 8,9 and 10).

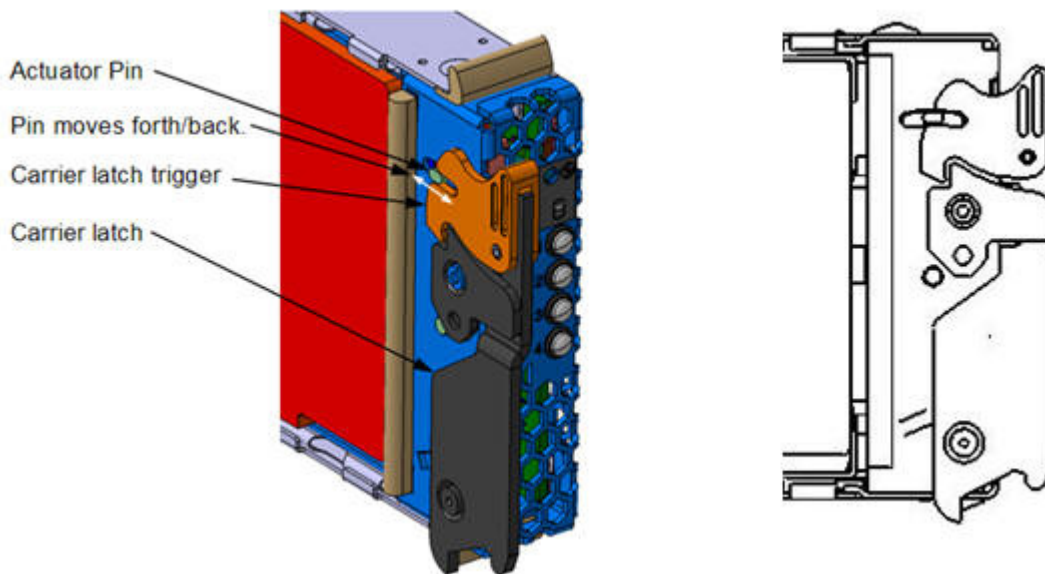
Figure 11 Electro-mechanical Actuator in Drive Carrier Latch (2 Views)

An electro-mechanical actuator locks the Drive Carrier's latch as soon as one or more drives are powered on in that Drive Carrier. This was implemented as a final check that the SSR has identified the correct Drive Carrier to remove in order to do the Drive service, as only the Drive Carrier being serviced will be unlocked. The actuator pin is moved to lock the latch trigger. See Figure 7 below. (The blue and red colors are only for contrast.)

NOTE – When the Drive Carrier is removed, if the actuator pin is accidentally moved to the locked position, it will be necessary to move gently back to the unlocked position with your finger before reinstalling the Drive Carrier.

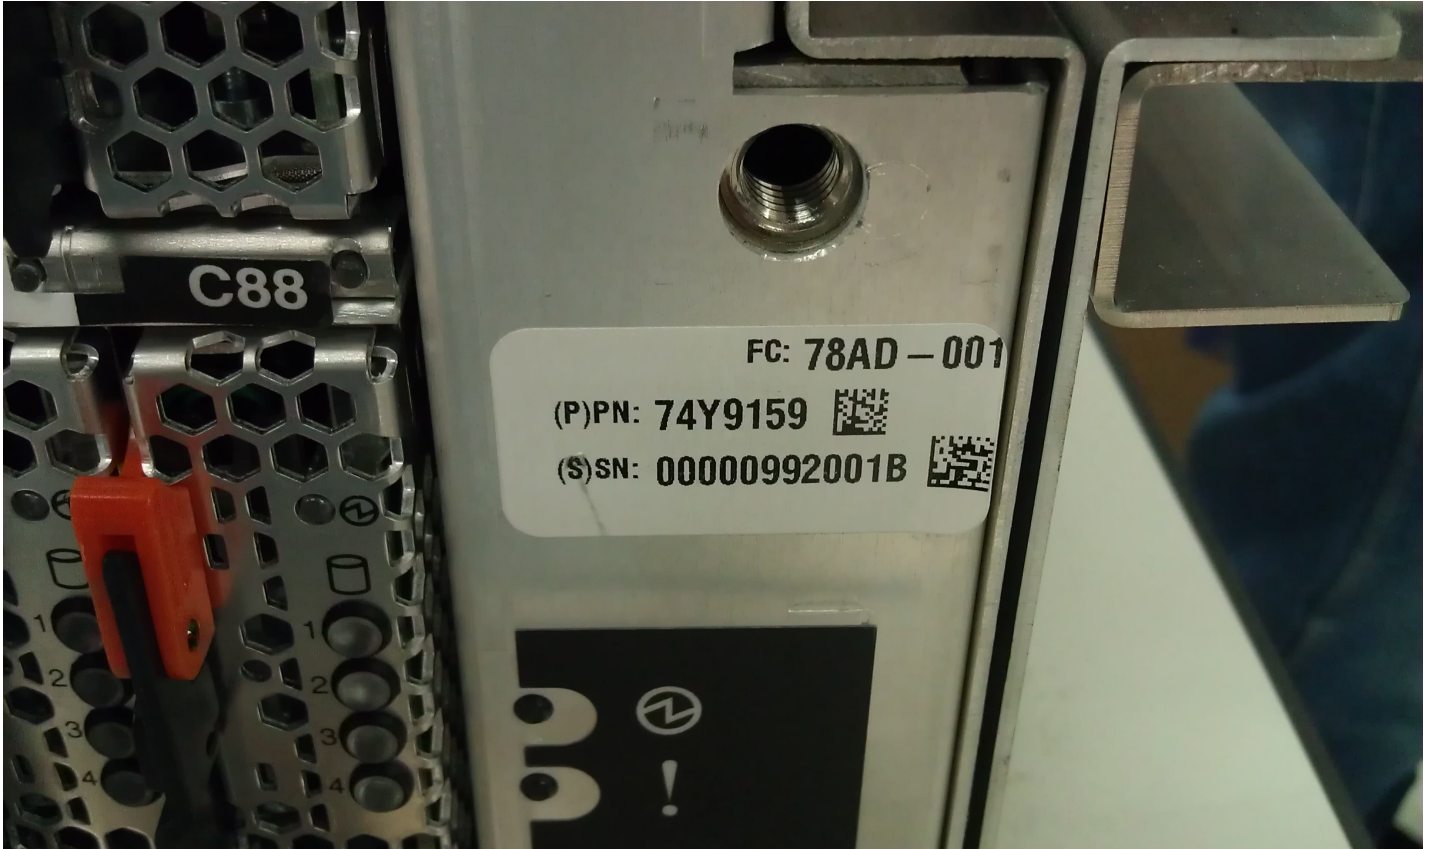
Figure 12 DE VPD Label

The VPD label is placed on the rear of a DE just above the drawer LEDs. The following picture shows the information contained in the label.

An example of a location code of Drive 4 in Drive Carrier 35 contained in the DE that this VPD label is attached to would be as follows:

U78AD.001.992001B-P1-C35-D4

Verify that the location code of the Drive Carrier to be replaced matches the enclosure VPD Label of the DE you have identified (see Figure 12).

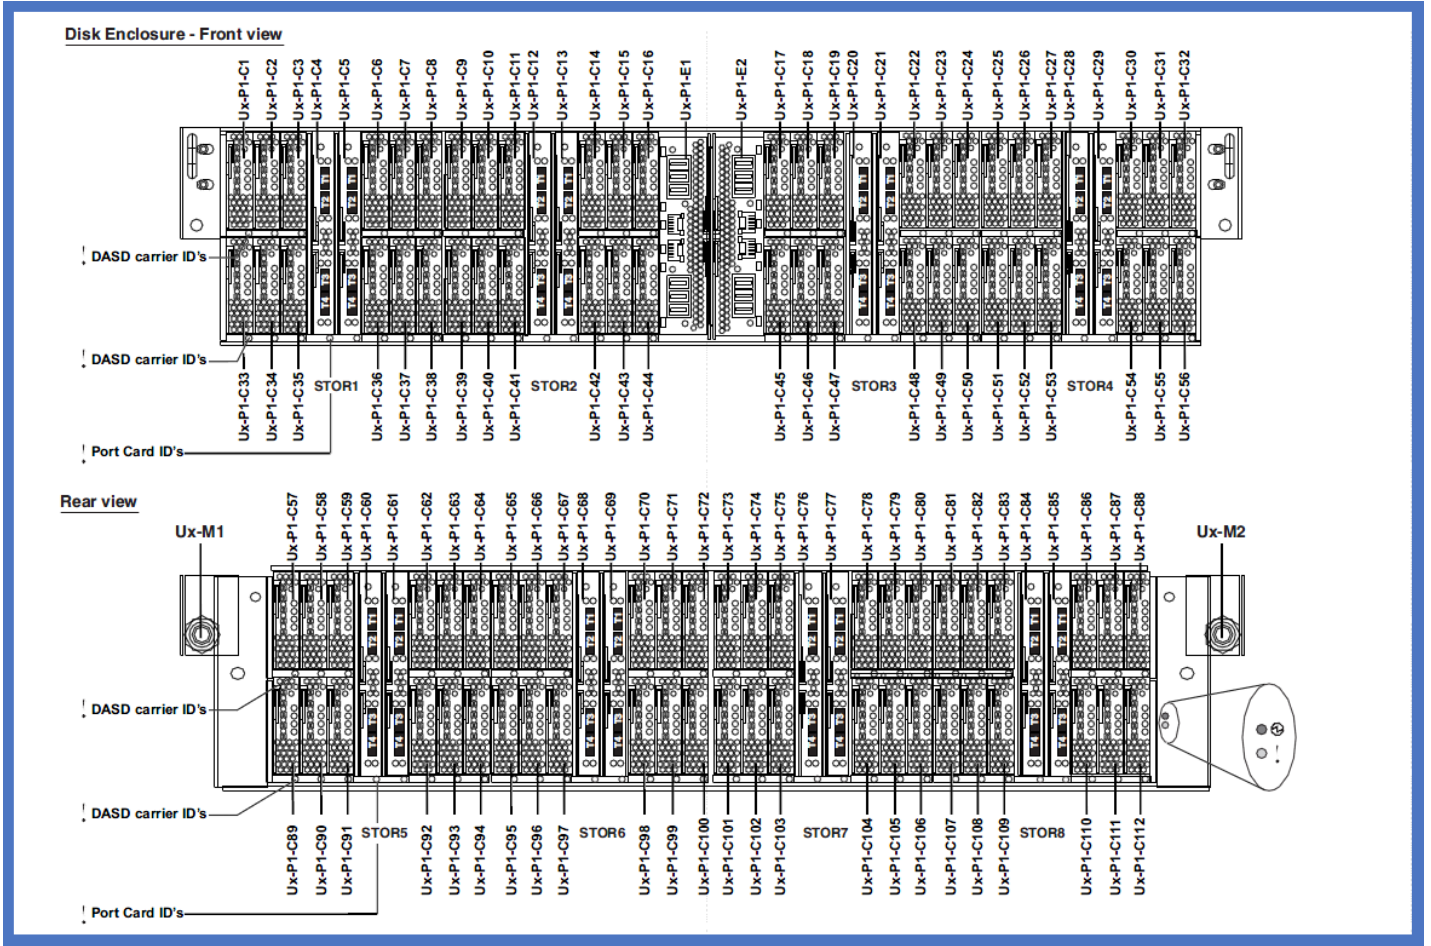
Figure 20 Disk Enclosure LEDs

NOTE: The Drive Carrier Slot ID and the Port Card Slot ID functions have 2 LEDs on the backplane going into a single light pipe. If the LED is not blinking, do not assume that the LED is broken as it is very unlikely that both are broken (see Figure 21) If this LED is not blinking, it is recommended to stop and contact next level of support.

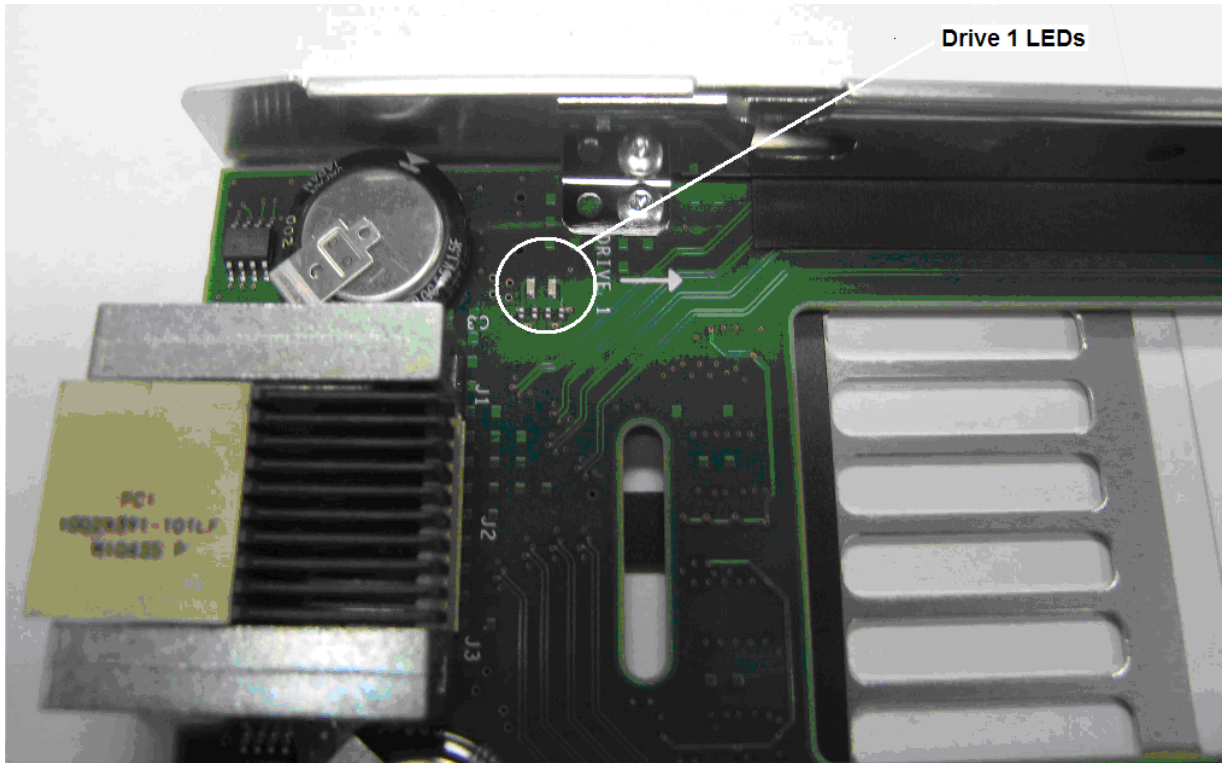
Figure 24 Drive 1 LEDs and arrow

- STEP 16 Confirm that the correct Drive Carrier has been removed by observing the LEDs. All 4 Drive Identify LEDs should be blinking. This is because all 4 drives were targeted with the mmhcarrier command. The blinking amber LEDs are next to a silk screen arrow pointing to the latch of the drive, and are labeled “Drive 1”, “Drive 2”, “Drive 3”, and “Drive 4” (see Figure 24 and Figure 25).

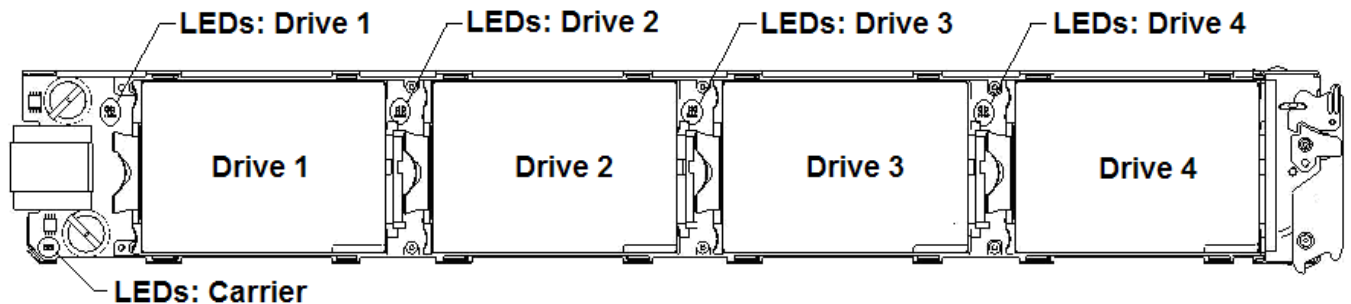
Figure 25 Drive Carrier LEDs and Drive Locations

NOTE: Ignore the LEDs labeled “Carrier” These will not blink when targeting the 4 drives.

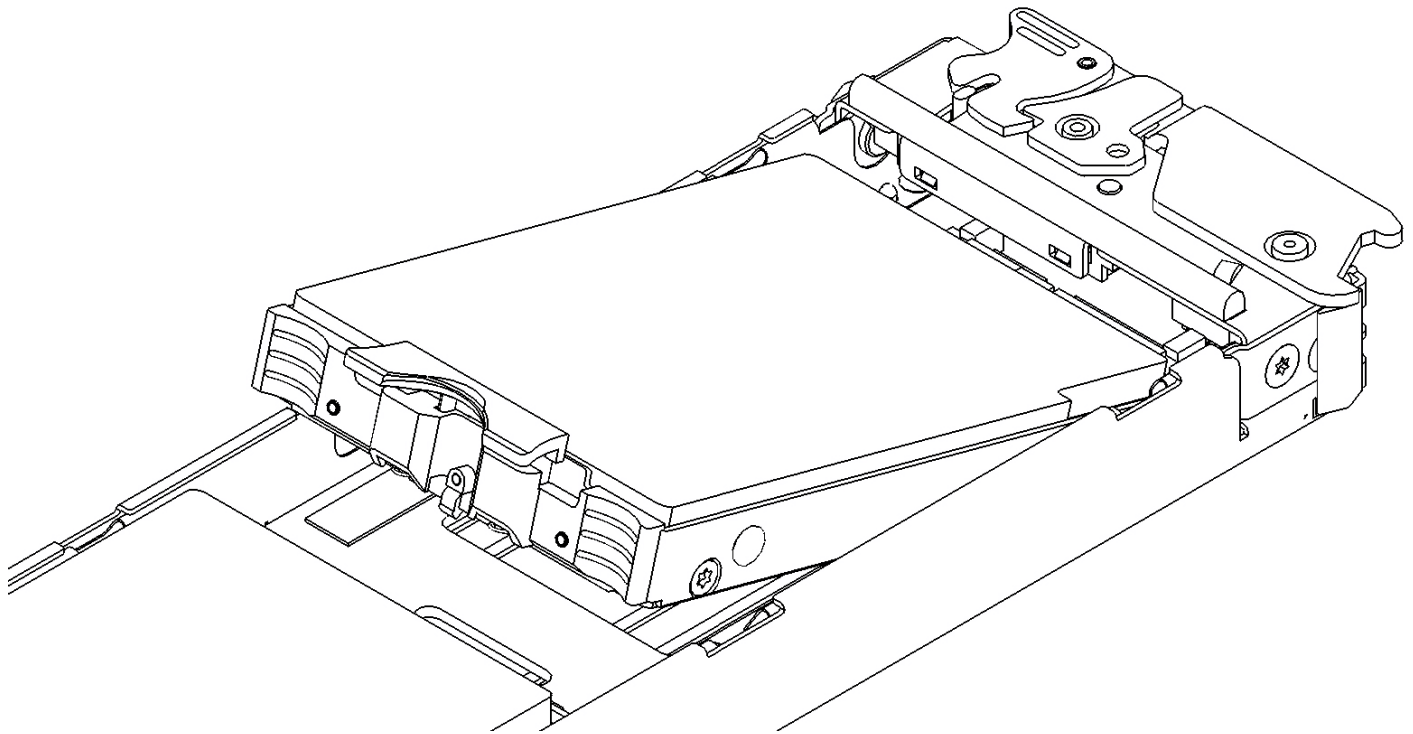
Figure 26 DRIVE Removal

- c. Lift the latch end first out of the Drive Carrier, followed by the connector end.
