Power 775 L-Link Optical Cables Service Procedure 11/30/2011

Power 775 L-Link Optical Cables Service Procedure

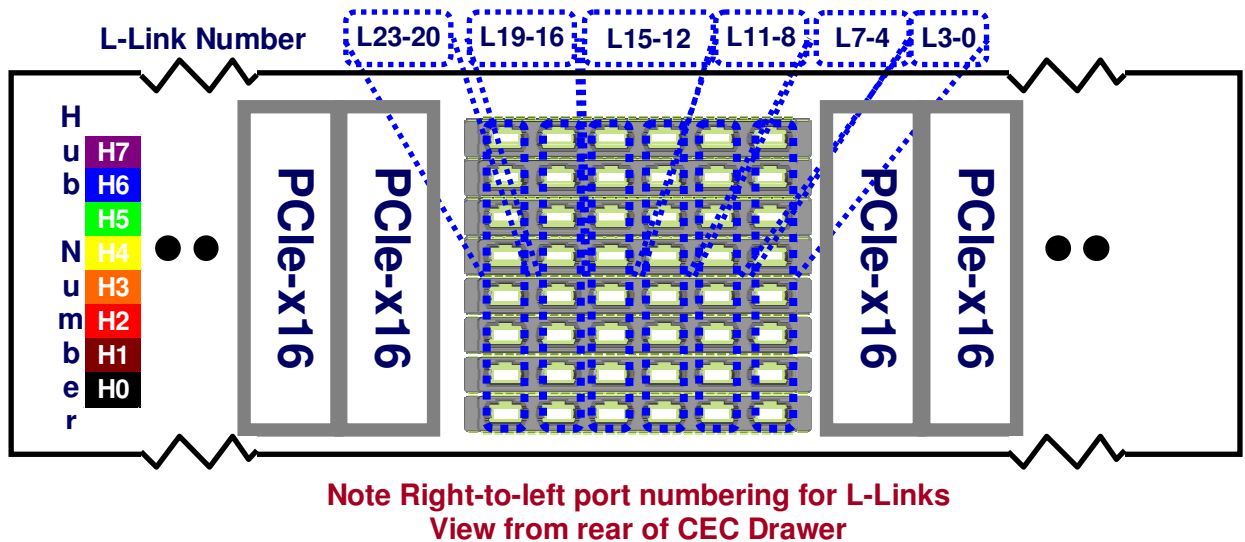
Figure 1 L-Link Port Numbering

Each Drawer has 48 of the 48-fiber L-Port optical connectors. The organization of these 48 connectors is shown in the figure below. Each 48-fiber connector carries signals for 4 of the (6+6)-fiber L-Ports.

The full L-Link Optical Backplane Enclosure holds and manages $4 * 48 = 192$ optical connectors.

Figure 1 describes the mapping between L-Ports that is implemented through the L-Link Optical Backplane. Each of the 32 Hubs in the SuperNode is connected to the 24 Hubs in the other 3 CEC drawers of the SuperNode through a (6+6) fiber bidirectional L-Link. The full L-Link Optical Backplane therefore contains $32 * 24 * (6+6) = 4,608$ optical fibers. There are $32 * 24 = 768$ individual (6+6) fiber links within the L-Link Optical Backplane Enclosure.

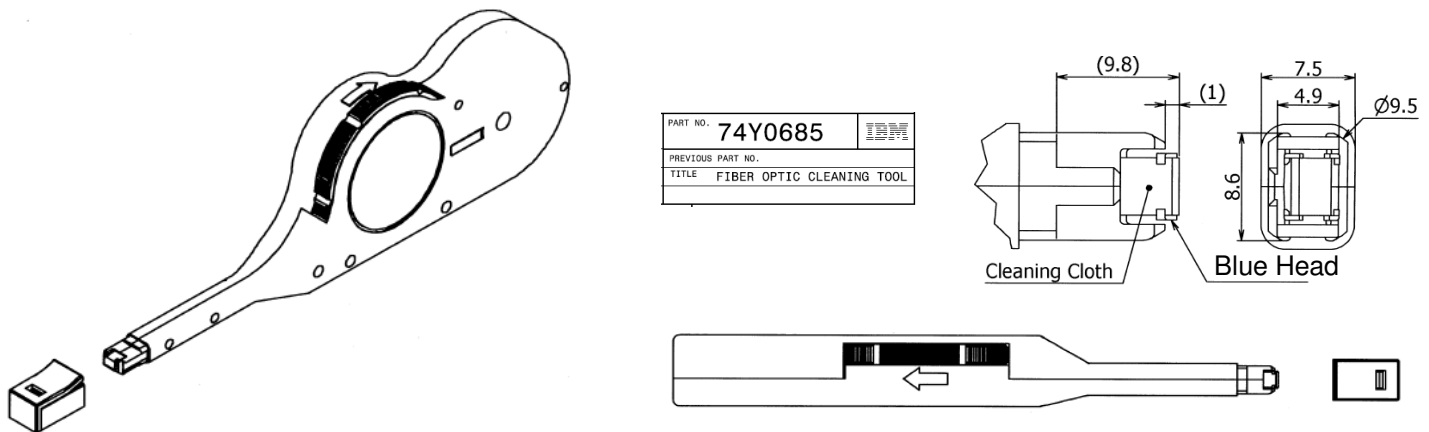
- Leave dust caps and dust covers on connectors and ports as much as possible,
- Ensure to never touch the end surfaces of the connectors, and
- Regularly use approved cleaning tools, such as the Fiber Optic Cleaning Tool shown below, preferably before each and every connector mating.

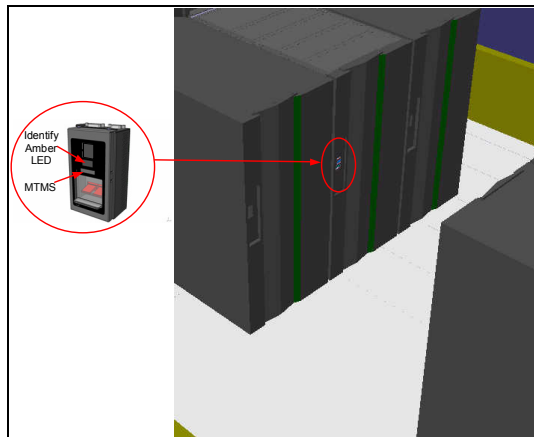
Figure 5 UEPO Identify LED location

- STEP 6 Locate the frame. The UEPO Identify Amber Led (see Figure 5) should be flashing. If the LEDs are not flashing, verify the FRU via MTMS (machine type model serial number). The rack level MTMS is located on the face of the UEPO (see Figure 5). Open the front and rear door of the frame.

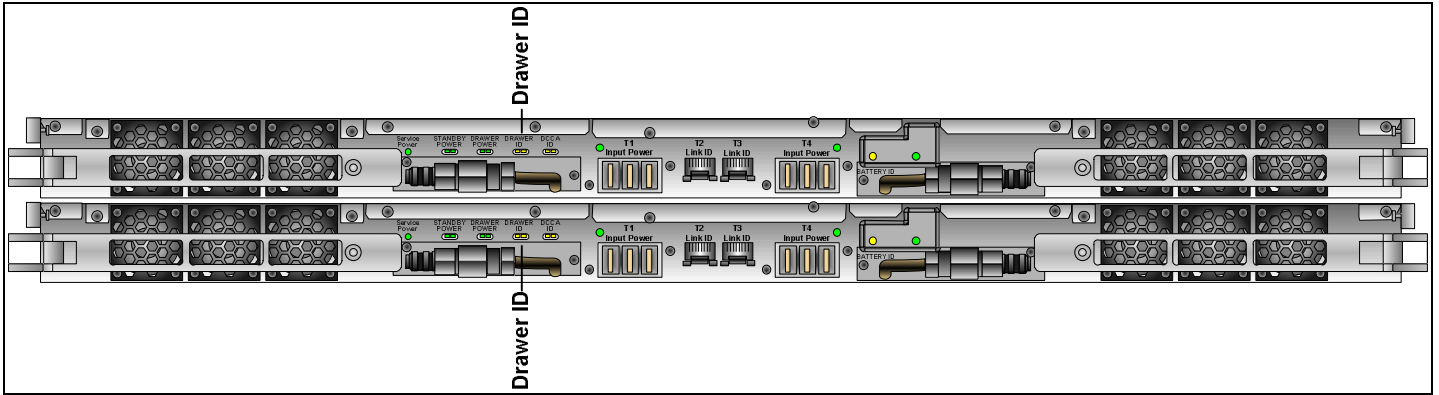
Figure 6 CEC Drawer ID – Front

STEP 7 Locate the CEC with the L-Link Cable requiring service. The CEC Drawer Identify LEDs (see Figure 6 and Figure 7) will be flashing. If the LEDs are not flashing, verify the FRU via MTMS (machine type model serial number).

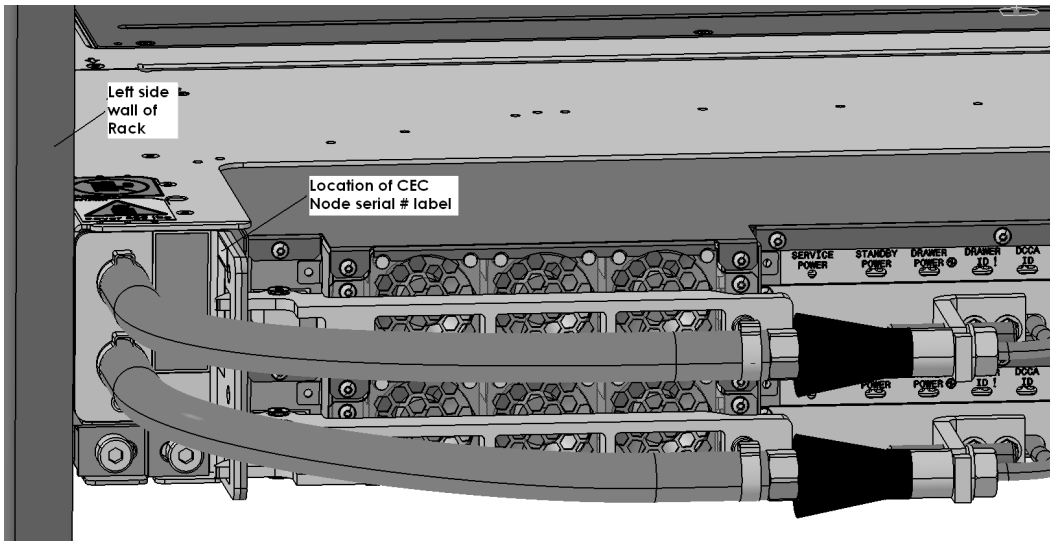
Figure 8 FRU Serial number location

STEP 8 Verify that the serial number on the CEC Enclosure VPD label (CEC Node serial # label) matches the location code of the L-Link OBE / L-Link Port requiring service (see Figure 8). This is the 7 digit serial number in the location code, show in bold below for example:
U78A9.001.**312N003**-P1-C15-T1-L3

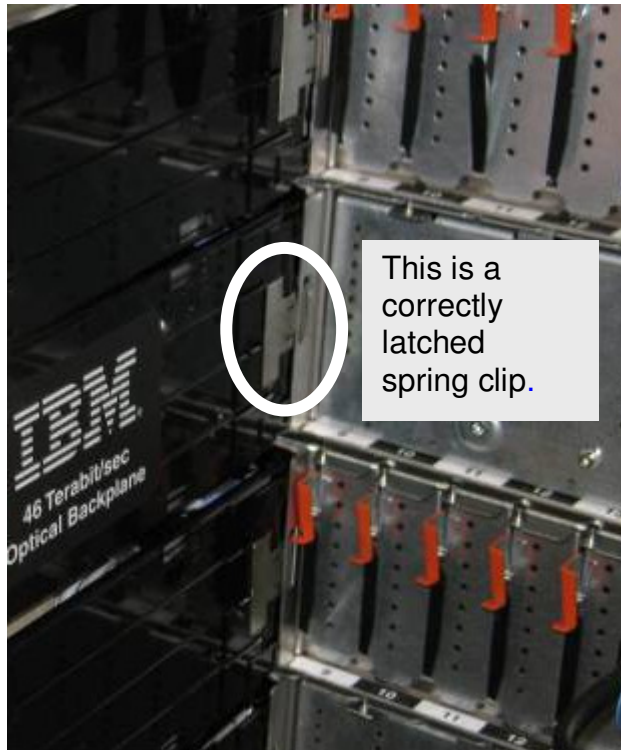
Figure 9 Correctly Latched Spring Clip

STEP 9 Ensure that all 8 spring clips holding the OBE to the CEC drawer are properly latched.

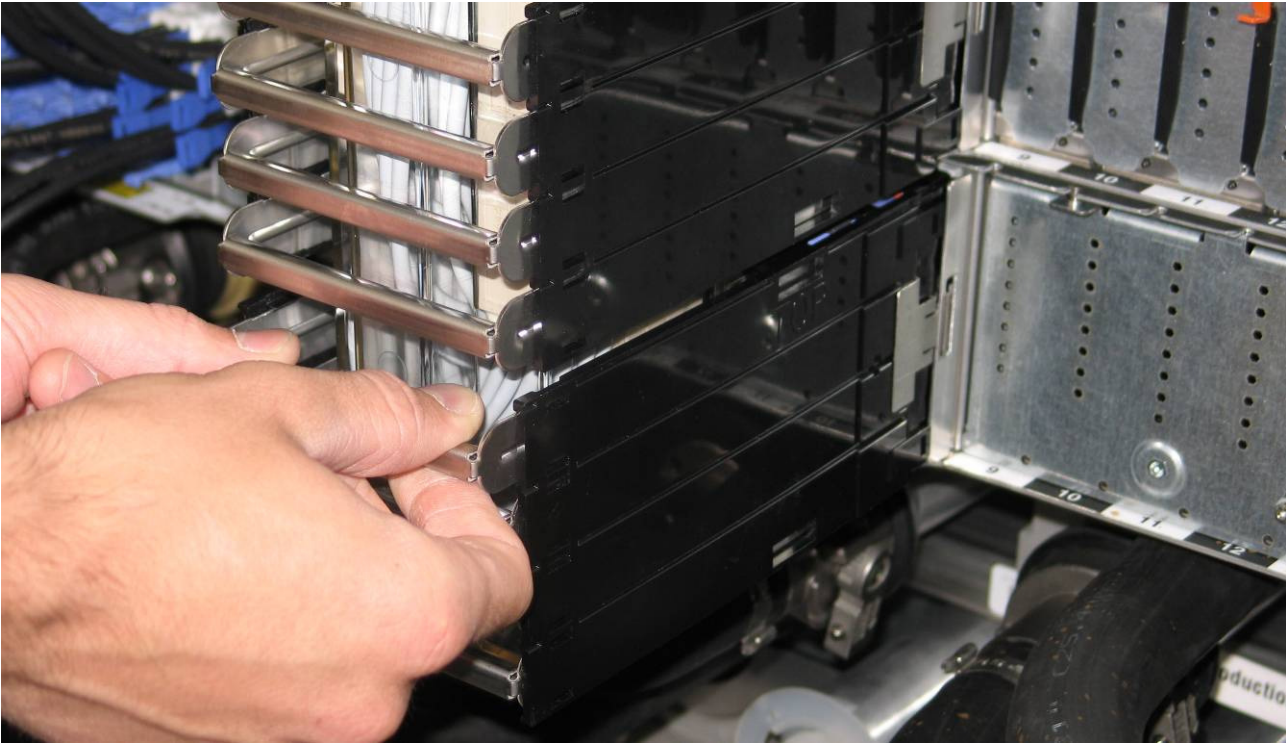
Figure 10 Pulling out handles

STEP 10 Pull out each of the 16 handles by ~10 mm to “unclick” each of the 12 MPO connectors per handle (see Figure 10 for how to hold the handles while pulling them out.).

CAUTION: Do not pull the handles more than 10 mm outward, to prevent over-bending of fibers.

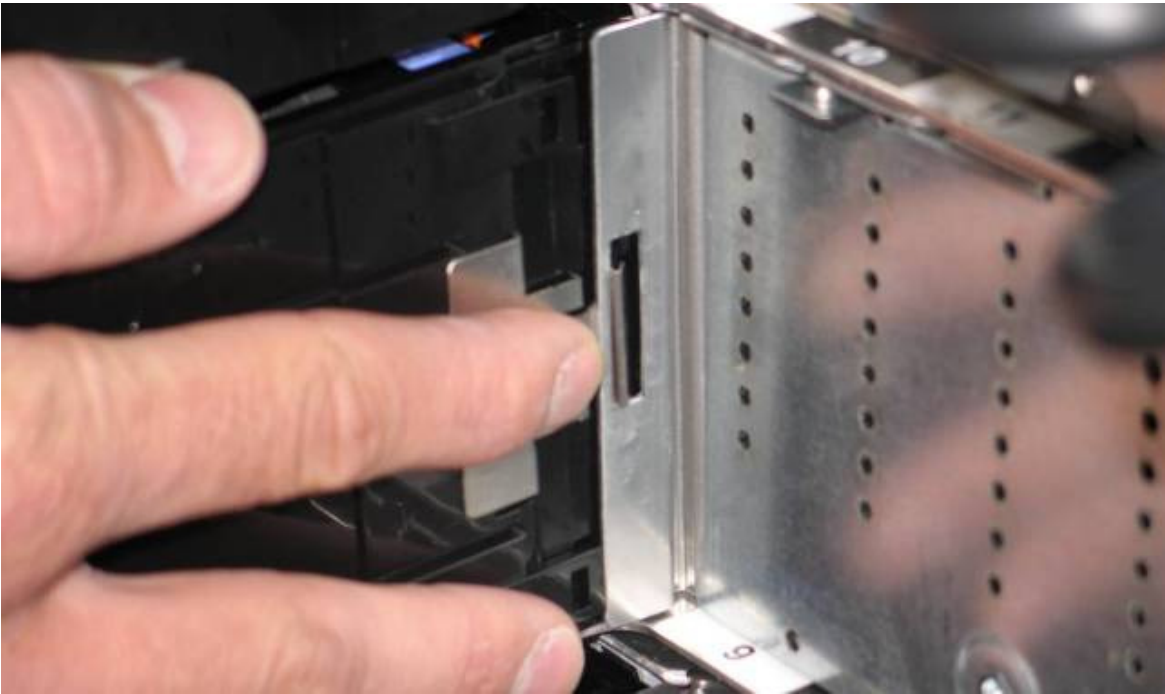
Figure 11 De-latch the OBE

- STEP 11 Working from the bottom Drawer of the SuperNode and moving upward, press in the 2 spring clips on either side of the optical backplane enclosures, to de-latch the OBE from the drawers, and pull the handle/sidewall assembly slightly outward to separate it from the CEC drawer (see **Figure 11**). Be sure to support the full OBE as the last two clips are removed (see **Figure 12**).

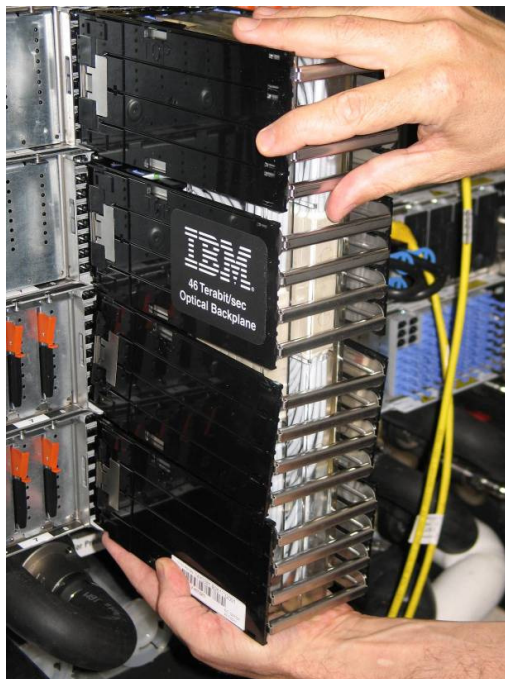
Figure 13 Support and remove OBE

- STEP 12 Being sure to support the OBE from below, remove the optical backplane enclosure from the CEC drawers (see **Figure 13**).

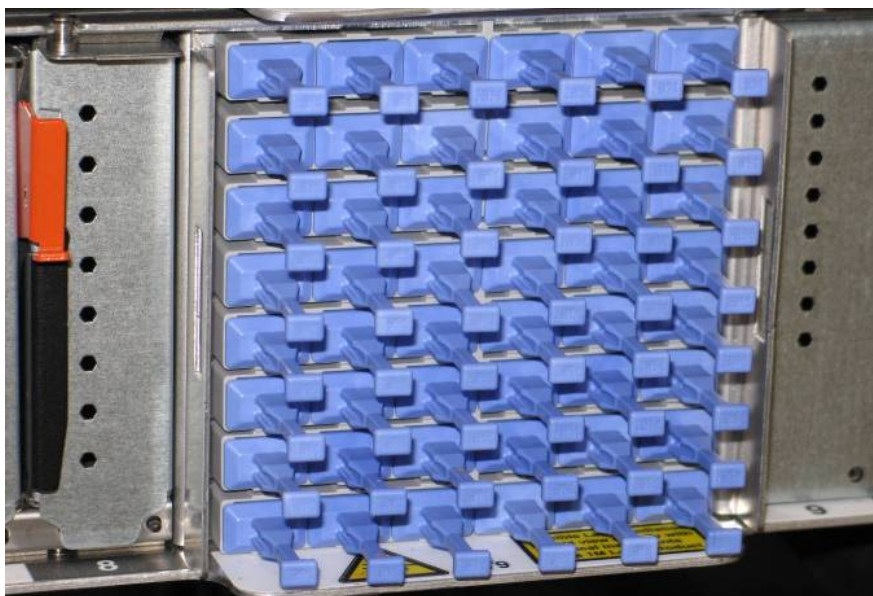
Figure 14 Removable Dust Plugs Inserted in L-Link Ports

- STEP 13 Set the OBE down on a sturdy surface with the connector front surfaces facing upward,
CAUTION: Be sure not to touch the front surface of the connectors, to prevent contamination of the optical surfaces.
- STEP 14 Put dust caps on all the connectors, to prevent contamination by dust or debris.
- STEP 15 If a new OBE will not be installed immediately, insert a Removable dust plug (IBM PN: 74Y0628, Optical “D” Link Single Plug, Removable) on each of the 192 L-Link ports of the 4 CEC drawers to protect the front faces of the L-Port optical connectors (see Figure 14). Alternately, insert 32 1x6 Gang Dust covers (IBM PN: 45D9902) on the ports.

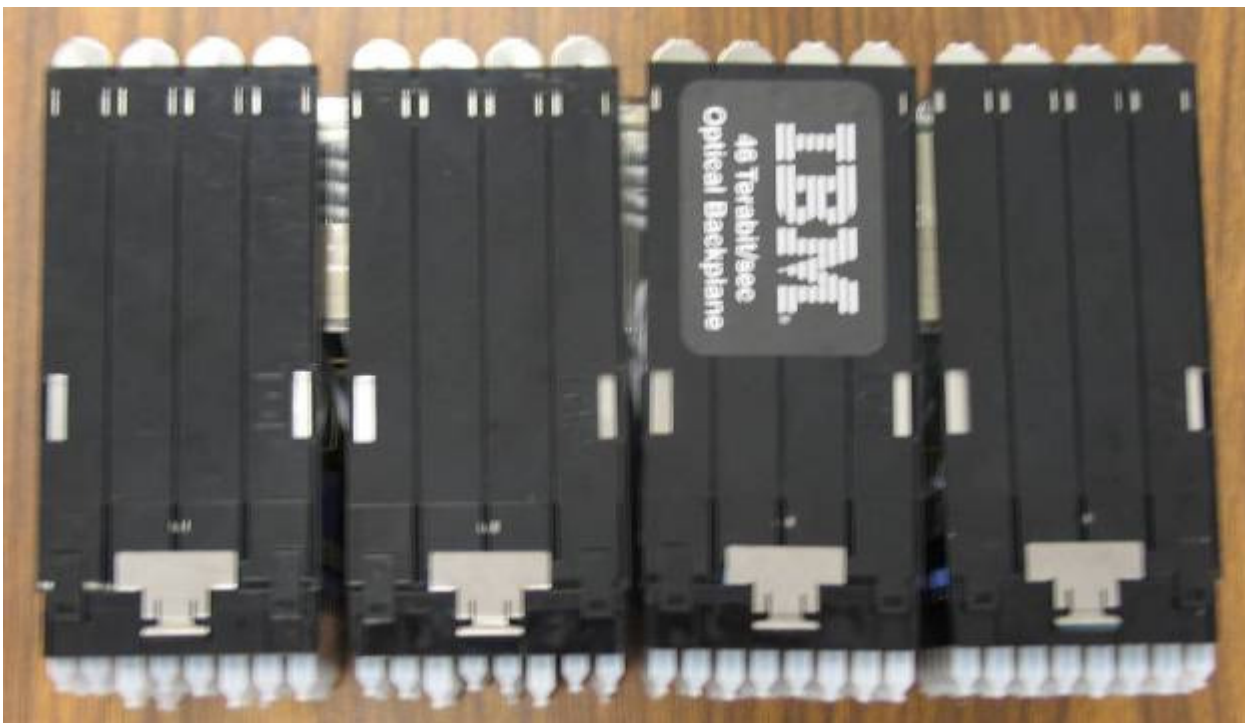
Figure 15 Unpacked OBE

STEP 18 Unpack the Optical Backplane Enclosure from the packaging (see Figure 15).

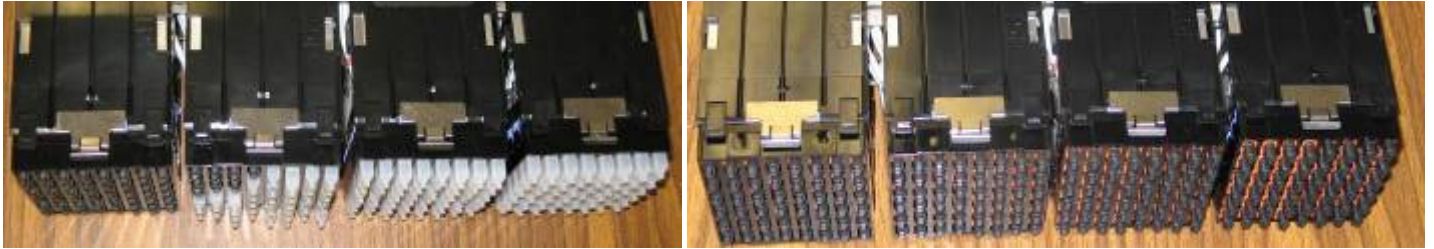
Figure 16 Remove Dust Covers

Inspect the fronts of the connectors to make sure that they are clean, dust-free, and undamaged. Clean any dust or debris from the front of the connectors using the optical connector cleaning tool (IBM PN: 74Y0685, Fiber Optic Cleaning Tool).

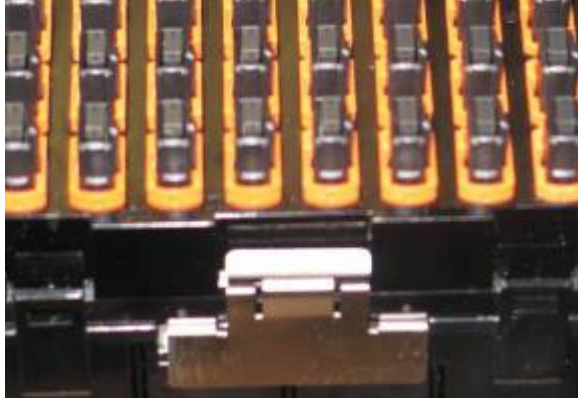
Figure 17 INCORRECT – MTP Connectors extended forward

Figure 17 shows incorrect configuration – connector surfaces are susceptible to damage during plugging.

- STEP 26 Working from top to bottom, using the handles, press each connector row to fully seat them. As each is fully seated, it will 'click' into place (see Figure 17)

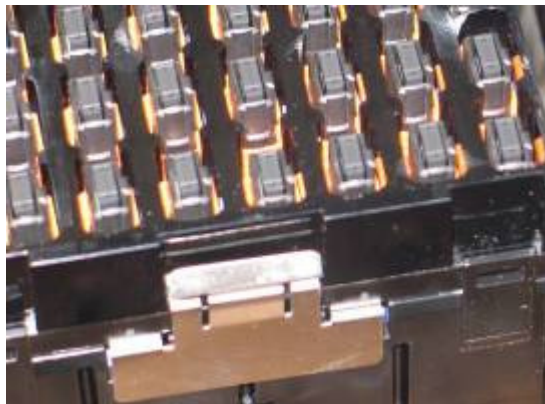
Figure 18 CORRECT - MTP Connectors all retracted

Figure 18 below shows correct configuration -- the connectors are all retracted and protected.

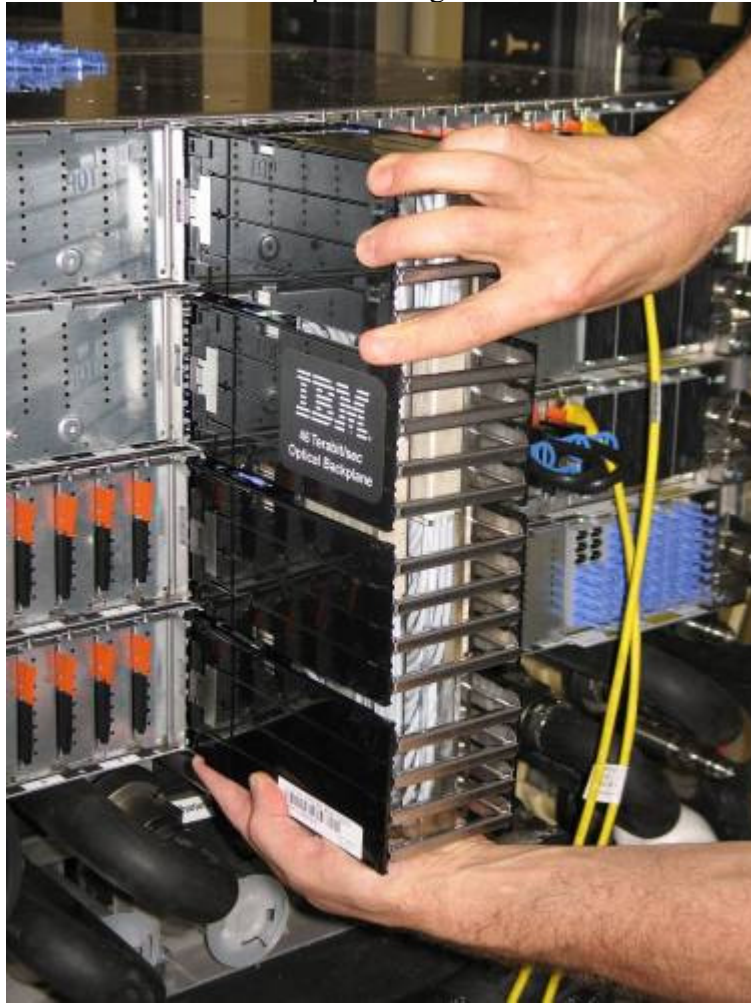
Figure 19 Orienting OBE

STEP 22 Orient the OBE near the 4 CEC drawers, with the "TOP" label at the top (see Figure 19).

- NOTE: While orienting, assure that the front surfaces of the optical connectors don't come into contact with the protruding sheet metal ribs on the CEC drawers.

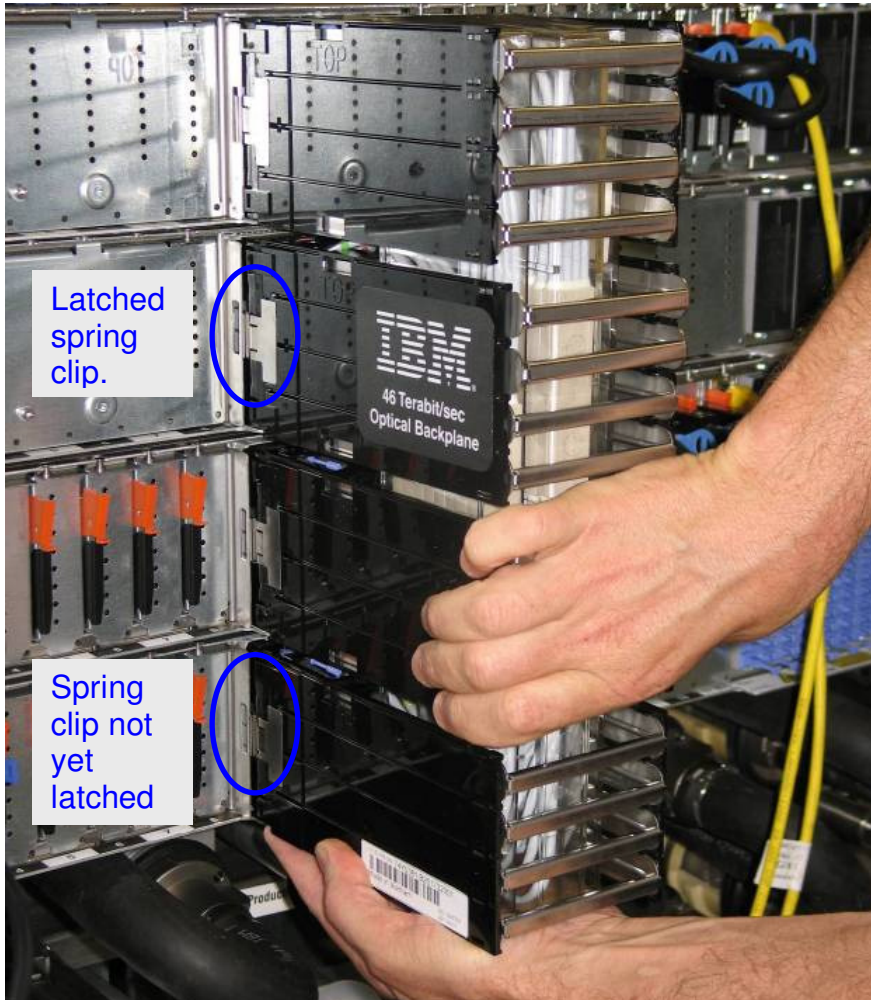
Figure 20 Spring clips latched and unlatched

- STEP 23 Latch the 8 spring clips to the 4 CEC drawers by pressing the sidewalls of the OBE in towards the CEC drawers. Repeat for the other 3 CEC drawers of the SuperNode, working from top to bottom (see Figure 20 and 21).
- During this step, the OBE must be supported manually. While not required, it may be easier to have a second person support the OBE while connectors are being inserted into the L-Ports.
 - It may be helpful to push inward on the two spring clips, to help ensure that they latch properly into the protruding sidewalls of the CEC drawers.

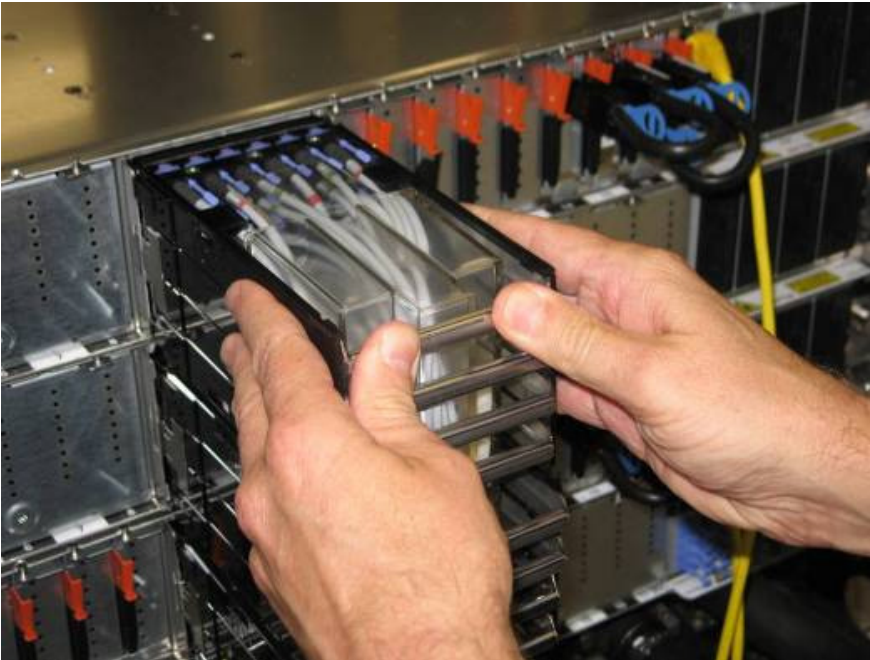
Figure 22 Final Seating of Connectors

- STEP 24 Partially insert the top two rows of connectors in the top handle into the top two rows of L-Link ports in the top CEC drawer of the Supernode. Follow with the next two rows of connectors in the next handle, and the remaining handles (16 pairs of rows), so that all connectors are partially inserted into the L-Link Ports in the 4 CEC drawers.
- STEP 25 Using the top handle, press in the connectors in the top two rows to fully seat them. This final seating is marked by an audible 'click' for each of the 12 MTP connectors. Each of the 16 handles is used to insert or extract 12 connectors, in 2 rows. Approximately 20 lbs of force will be required for each of the handles to fully actuate all 12 connectors during insertion (see Figure 22).

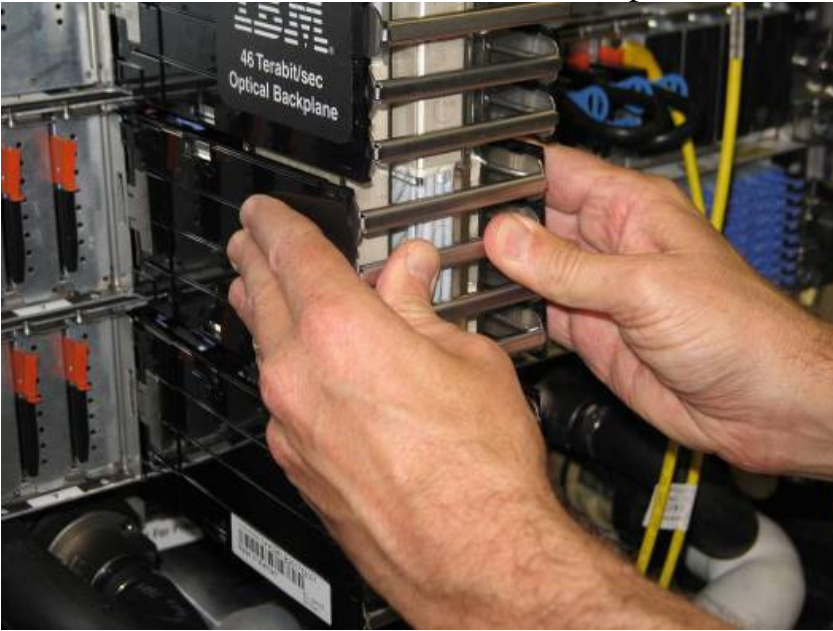
Figure 23 Pressing a handle in

Note: A relatively large amount of force – between 20 and 28 lbs – is required for each handle, to fully seat the connectors behind each handle, since each connector requires approximately 1.5 to 2.0 lbs of seating force. There is little danger of damaging any OBE pieces, if the initial insertion of each connector describing in STEP 24 has been properly executed.

- STEP 27 Repeat the previous step – again press in each of the 16 handles with roughly 25 lbs. of force while rocking the handle upward and downward until no more clicks can be heard on any of the handles, to assure that all 12 MTP connectors per handle are fully actuated.
- STEP 28 Run the `lsnwlinfo` command to ensure that all L-Links in the SuperNode are in the `UP_OPERATIONAL` status.
- Note: It is necessary to run the `lsnwlinfo` on all 4 CEC drawers, to ensure that all links are operational.
 - Two possible calling formats are possible, either
`lsnwlinfo -f <frame> -c <cage> // <frame> as numbered, <cage> in frame, range 3 – 14`
or
`lsnwlinfo -s <supernode> -d <drawer> // <drawer> in SuperNode, range 0-3`
 - Calling syntax for the `lsnwlinfo` command is described in Section 2.11

SOME FORCE IS REQUIRED. A relatively large amount of force – 20 to 28 lbs (9 to 13kg)– is required for each handle, to fully seat the connectors behind each handle, since each connector requires approximately 1.5 to 2.0 lbs of seating force. There is little danger of damaging any OBE pieces, if the initial insertion of each connector that will be described in STEP 24 has been properly executed.

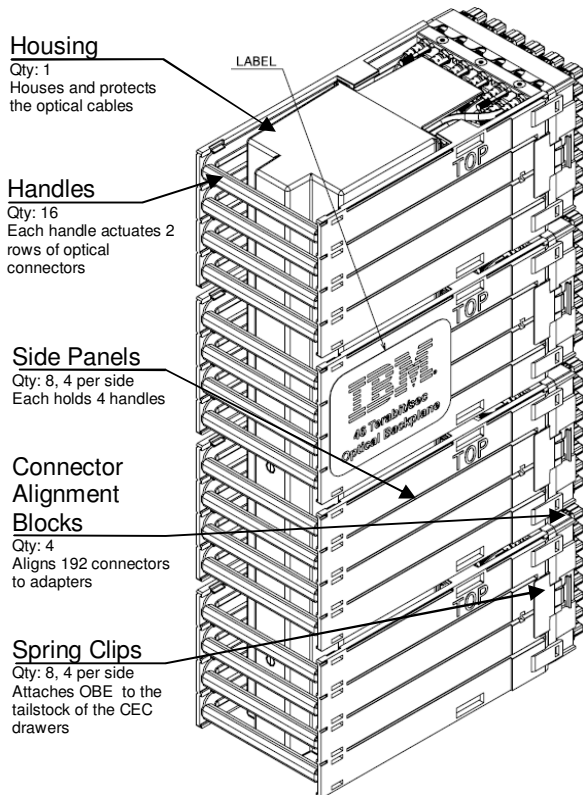
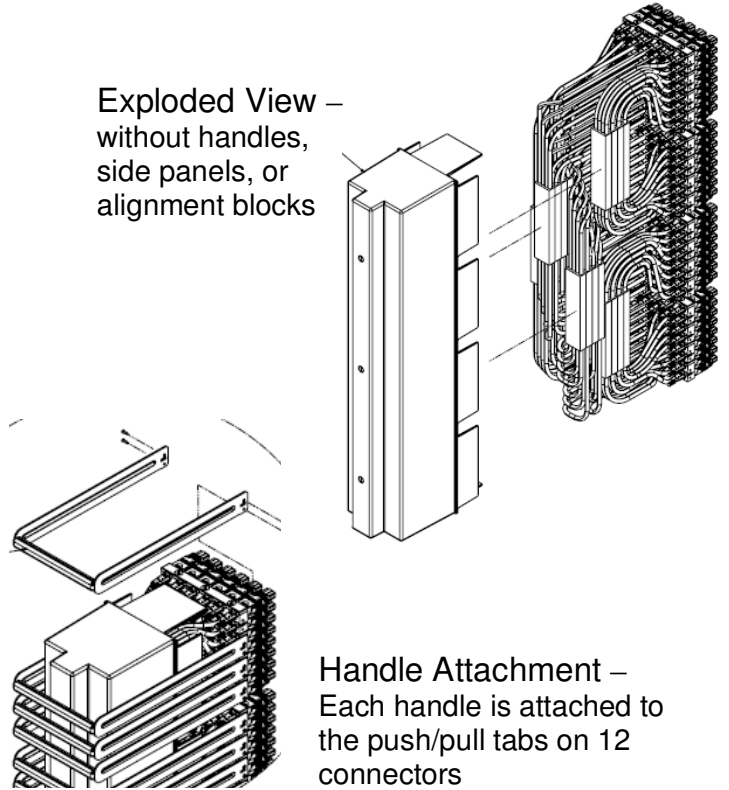
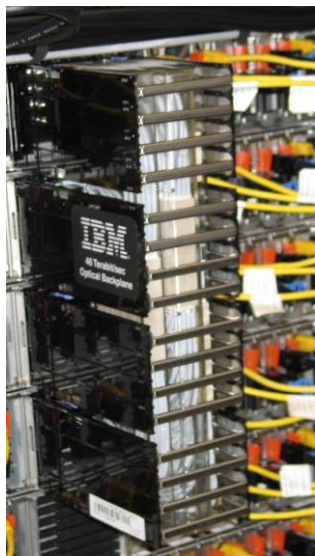
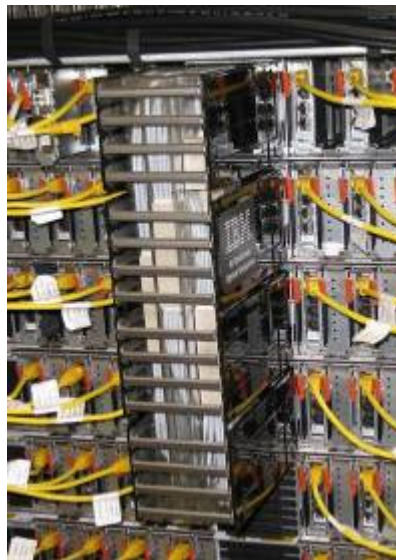
Optical Backplane Enclosure (OBE)

The L-Links that interconnect the 4 CEC drawers of a SuperNode are all enclosed within an enclosure, termed the Optical Backplane Enclosure (OBE). This OBE organizes and protects the L-Link optical shuffle cables that interconnect the 32 Hubs of the SuperNode.

Exploded View – without handles, side panels, or alignment blocks
