Release Notes for the Catalyst 4500 Series Switch, Cisco IOS Release 12.2(31)SGA

Current Release
12.2(31)SGA—September 11, 2006

These release notes describe the features, modifications, and caveats for the Cisco IOS software on the Catalyst 4500 series switch. The most current software release is Cisco IOS Release 12.2(31)SGA.

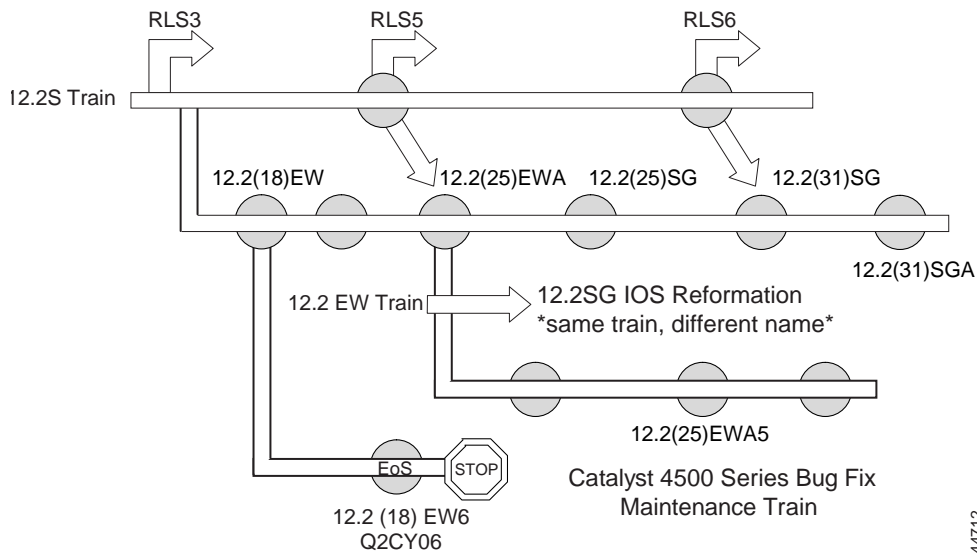
Figure 1 Software Release Strategy for the Catalyst 4500 Series Switch

Figure 1 displays the Cisco IOS Software Release 12.2(31)SGA plan relative to the 12.2S and 12.1 releases, and identifies the recommended migration path.

Summary of Migration Plan

Releases 12.2(18)EW and 12.2(25)EWA will continue offering maintenance releases.
