**IBM System Storage SAN Volume Controller**

# **Service Guide - Errata**

**Version 4.2.1**

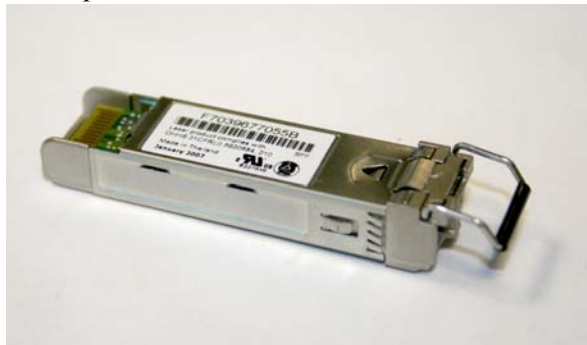
Use the following steps to remove and replace a Small Form-factor Pluggable connector (SFP). These instructions apply to all model types.

**Note:** The SFP FRU is capable of operating at up to 4 Gb/s; on the 2145-8F2 and 2145-4F2 its maximum speed is limited to 2Gb/s by the fibre-channel adapter.

The SFPs are designed to be hot-plugged, so the SAN Volume Controller node need not be powered off before replacement. Normal precautions for handling laser products should be followed. The procedure for removing and replacing a SFP is:

1. Carefully determine the failing physical port connection. Refer to the SAN Volume Controller Service Guide for the port positions. Removing the wrong SFP could result in loss of data access.
2. Remove the fibre-channel cable by pressing the release tab and pulling the connector out. Be careful to only exert pressure on the cable connector and not to pull on the fibre-channel cables themselves.
3. Remove the SFP. There are a number of different handling / locking mechanisms used on SFPs. The table below indicates the usual type found on a model. It is possible, however, that the installed SFPs have a different mechanism to that indicated:
