IBM System Storage SAN Volume Controller Troubleshooting Guide

Version 6.1.0

GC27-2284-00

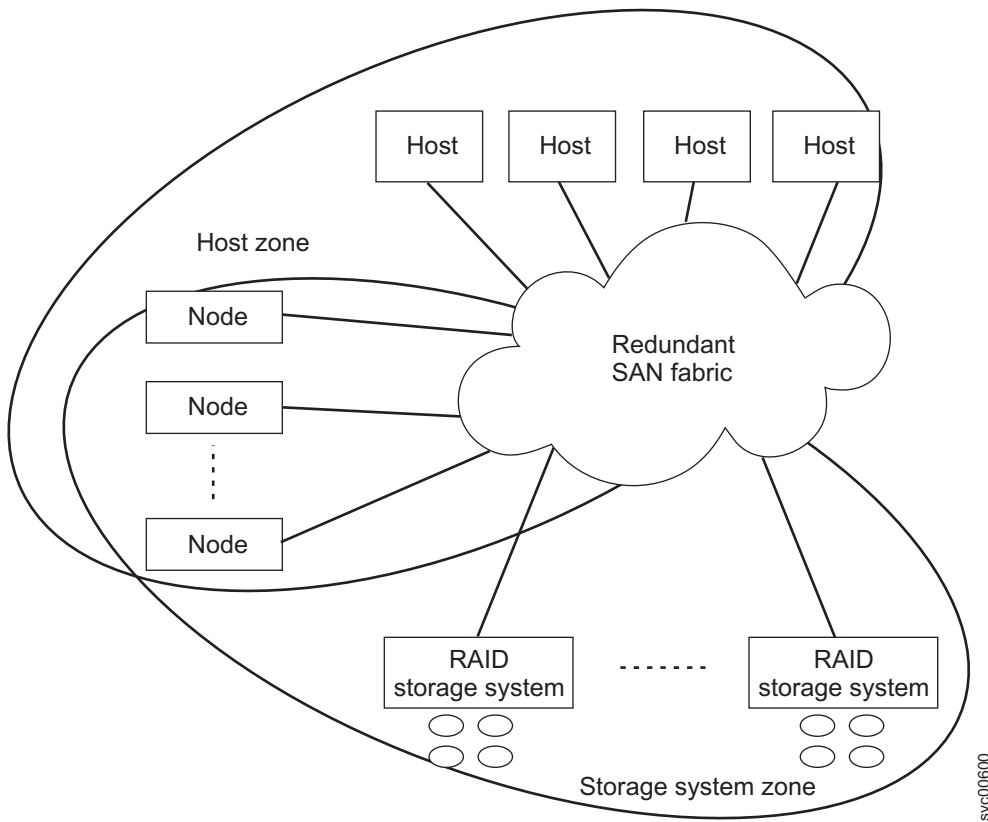
| Figure 1 on page 2 shows hosts, SAN Volume Controller nodes, and RAID storage systems connected to a
| SAN fabric. The redundant SAN fabric comprises a fault-tolerant arrangement of two or more
| counterpart SANs that provide alternate paths for each SAN-attached device.

Figure 1. SAN Volume Controller system in a fabric

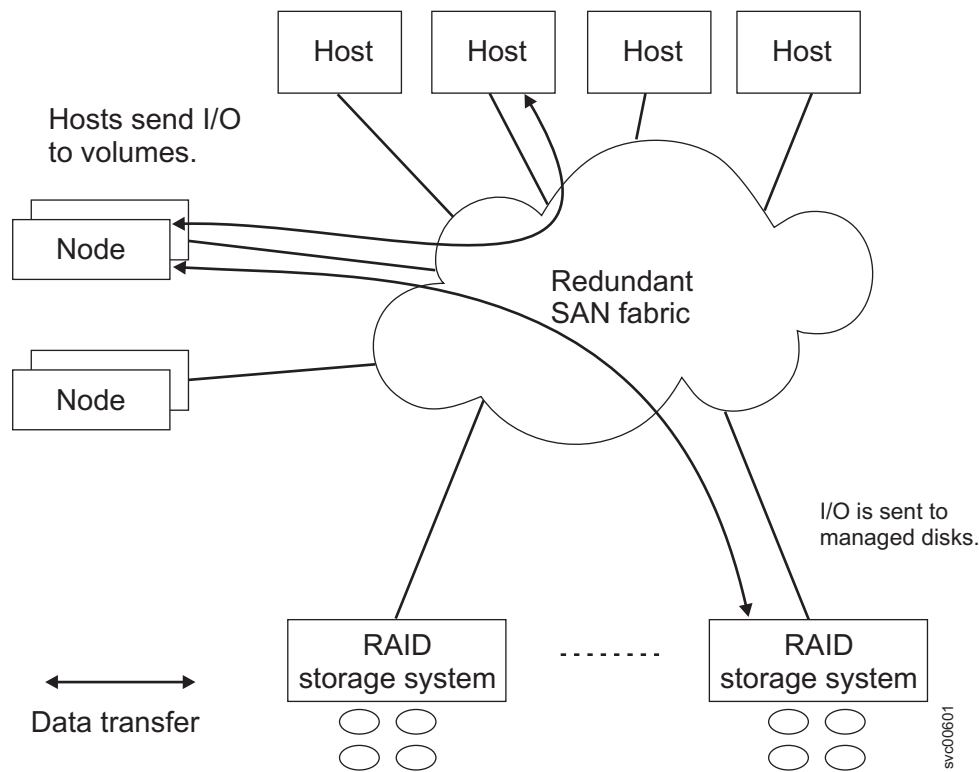
A cluster of SAN Volume Controller nodes present volumes to the hosts. Most of the advanced functions that SAN Volume Controller provides are defined on volumes. These volumes are created from managed disks (MDisks) that are presented by the RAID storage systems. All data transfer occurs through the SAN Volume Controller nodes, which is described as symmetric virtualization.

Figure 2 shows the data flow across the fabric.

Figure 2. Data flow in a SAN Volume Controller system

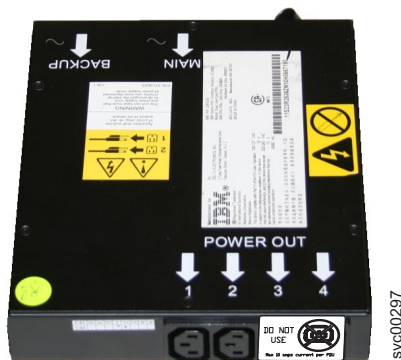
Figure 41. Photo of the redundant ac-power switch

The redundant ac-power switch is an optional feature that makes the SAN Volume Controller nodes resilient to the failure of a single power circuit. The redundant ac-power switch is not a replacement for an uninterruptible power supply. You must still use a uninterruptible power supply for each node.

Figure 41 shows a redundant ac-power switch.
