*Problem Determination and Service
Guide for the IBM PS703 (7891-73X)
and PS704 (7891-74X)*

This edition applies to IBM Power Systems servers that contain the POWER7 processor and to all associated models.

This problem determination and service information helps you solve problems that might occur in your IBM BladeCenter® PS703 or PS704 blade server. The information describes the diagnostic tools that come with the blade server, error codes and suggested actions, and instructions for replacing failing components.

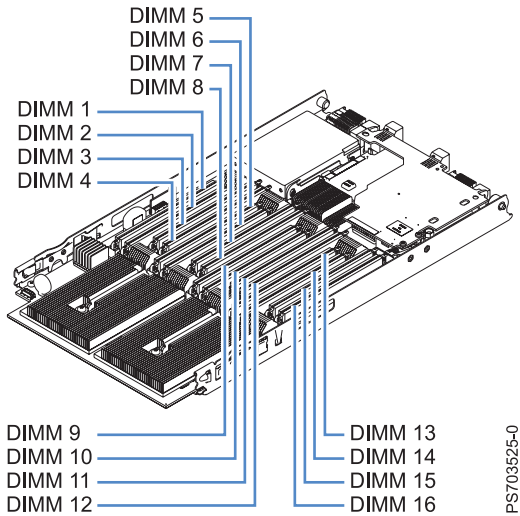
Table 1. Memory module combinations for the PS703 blade server

Figure 1. DIMM connectors for the PS703

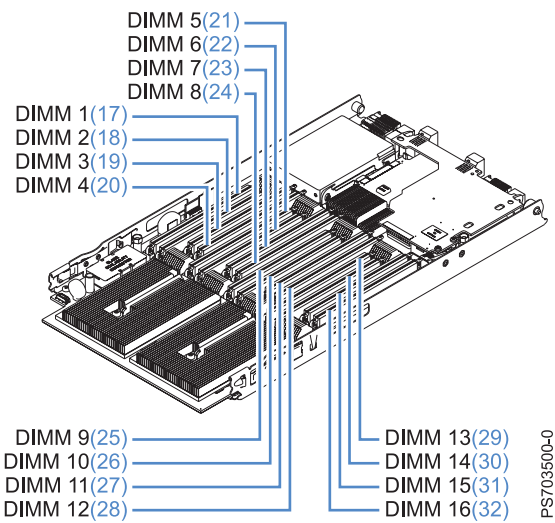
Table 2. Memory module combinations for the PS704 blade server

Figure 2. DIMM connectors for the PS704

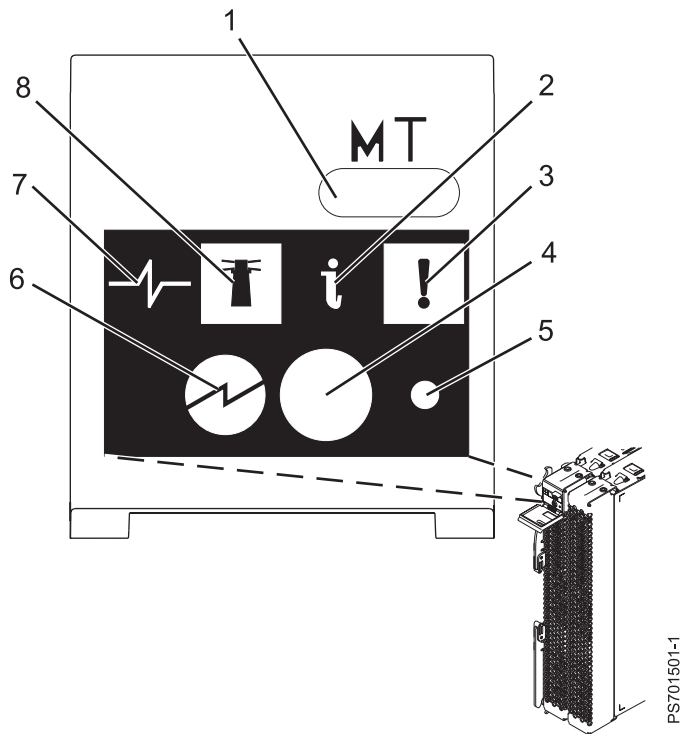
Note: Figure 3 shows the control-panel door in the closed (normal) position. To access the power-control button, you must open the control-panel door.

Figure 3. Blade server control panel buttons and LEDs

- 1 Media-tray select button:** Press this button to associate the shared BladeCenter unit media tray (removable-media drives and front-panel USB ports) with the blade server. The LED on the button flashes while the request is being processed, then is lit when the ownership of the media tray has been transferred to the blade server. It can take approximately 20 seconds for the operating system in the blade server to recognize the media tray.

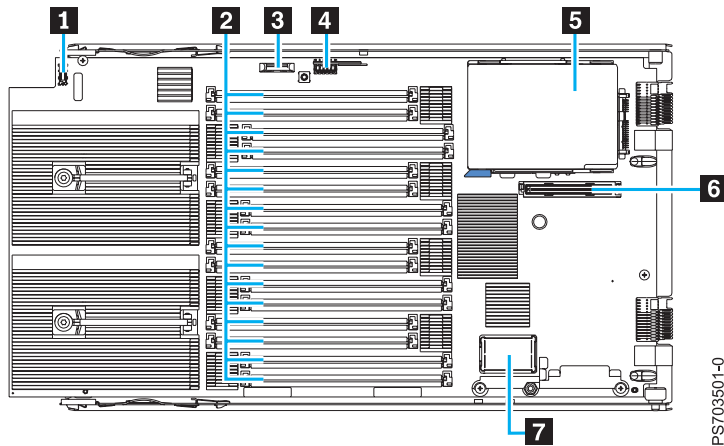
The following figure shows the connectors on the base-unit system board in the PS703 blade server.

Figure 4. PS703 system-board connectors

Callout	PS703 blade server connectors
1	Operator panel connector
2	DIMM connectors (See Figure 7 on page 11 for individual connectors.)
3	3 V lithium battery connector (P1-E1)
4	Management card connector (P1-C17)
5	2.5" SAS HDD (P1-D1) or 1.8" SATA SSD (P1-C18, P1-C18-D1, P1-C18-D2) carrier
6	CIOv expansion card connector (P1-C19)
7	High-speed (CFFh) expansion card connector (P1-C20)

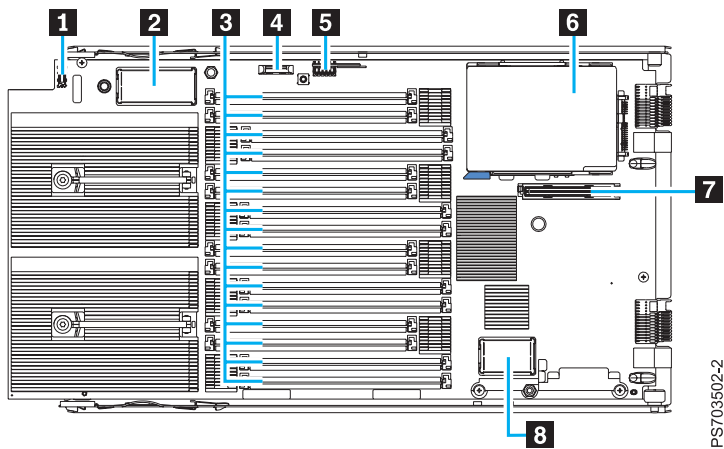
The following figure shows the connectors on the base-unit system board in the PS704 blade server.

Figure 5. PS704 system base-unit connectors

Callout	PS704 blade server connectors
1	Operator panel connector
2	Expansion connector
3	DIMM connectors (See Figure 8 on page 11 for individual connectors.)
4	3 V lithium battery connector (P1-E1)
5	Management card connector
6	2.5" SAS HDD (P1-D1) or 1.8" SATA SSD (P1-C18, P1-C18-D1, P1-C18-D2) carrier
7	CIOv expansion card connector (P1-C19)
8	High-speed (CFFh) expansion card connector (P1-C20)
9	DIMM connectors (See Figure 8 on page 11 for individual connectors.)
10	2.5" SAS HDD (P2-D1) or 1.8" SATA SSD (P2-C18, P2-C18-D1, P2-C18-D2) carrier
11	CIOv expansion card connector (P2-C19)

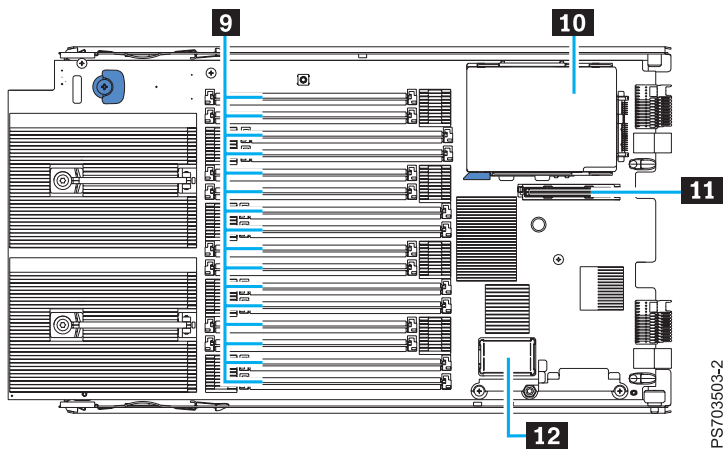
The following figure shows the connectors on the expansion-unit system board in the PS704 blade server.

Figure 6. PS704 system expansion-unit connectors

Callout	PS704 blade server connectors
12	High-speed (CFFh) expansion card connector (P2-C20)

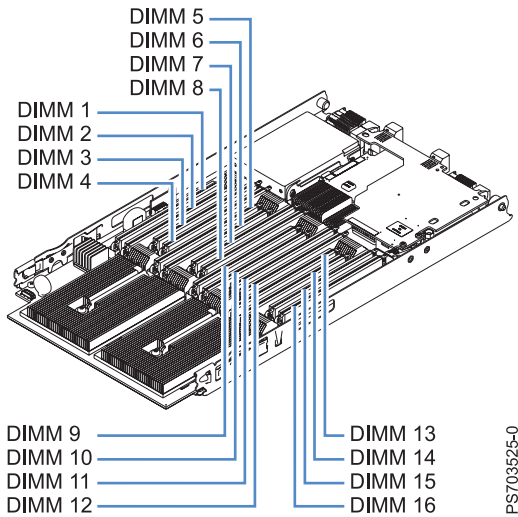
Figure 7 shows individual DIMM connectors for the PS703 system board.

Figure 7. DIMM connectors for the PS703

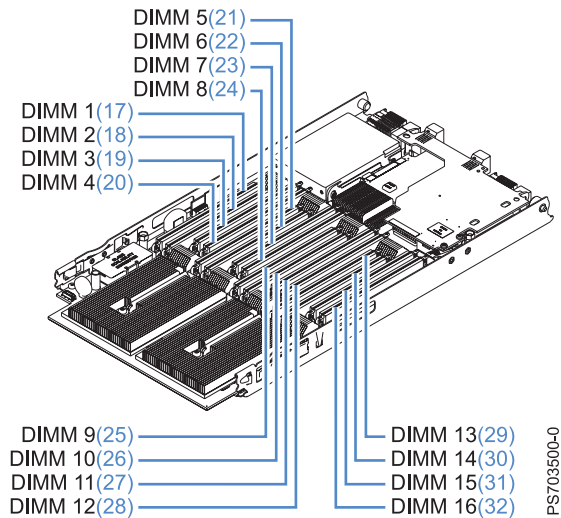
Figure 8 shows individual DIMM connectors for the PS704 system board. The numbers in parentheses are for the PS704 expansion-unit system board.

Figure 8. DIMM connectors for the PS704

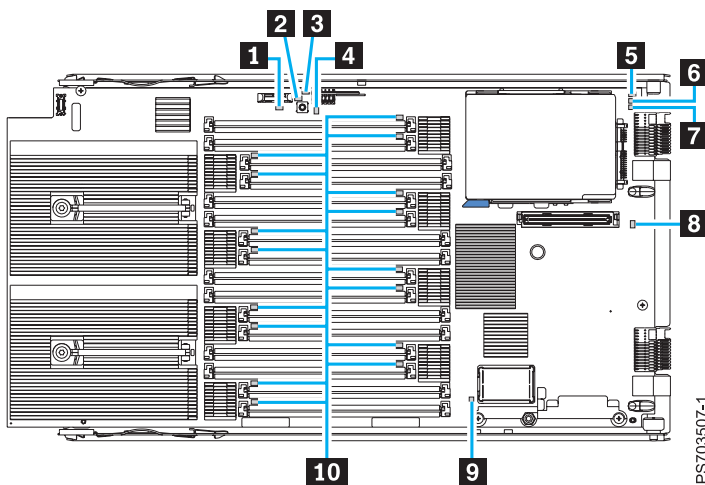
The following figure shows LEDs on the PS703 blade server.

Figure 9. LED locations on the system board of the PS703 blade server

Remove the blade server from the BladeCenter unit, open the cover, press the blue button to see any error LEDs that were turned on during error processing. Use Figure 9 to identify the failing component.

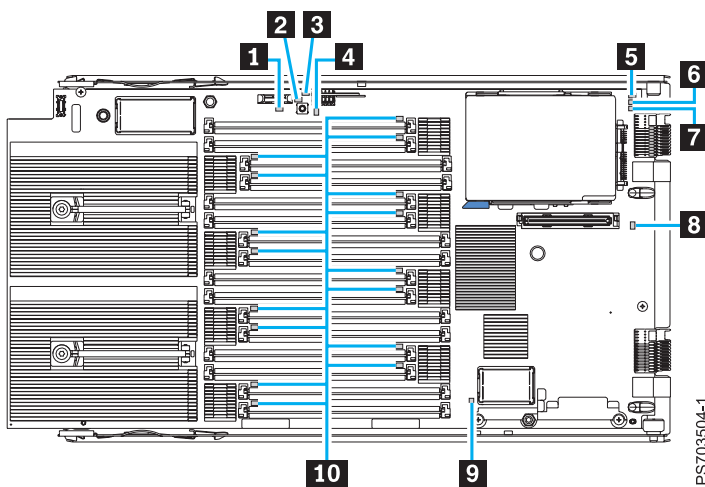
The following figure shows LEDs on the base system board of the PS704 blade server.

Figure 10. LED locations on the base system board of the PS704 blade server

If the "Check card below LED" is lit on the PS704 expansion-unit system board, remove the expansion unit and push the blue button on the base-unit system board to view LEDs on the system board of the base unit.

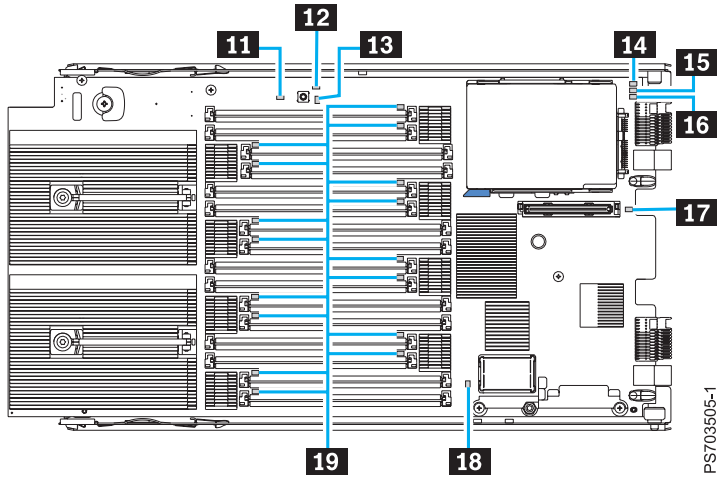
The following figure shows LEDs on the expansion-unit board of the PS704 blade server.

Figure 11. LED locations on the board of the PS704 expansion unit

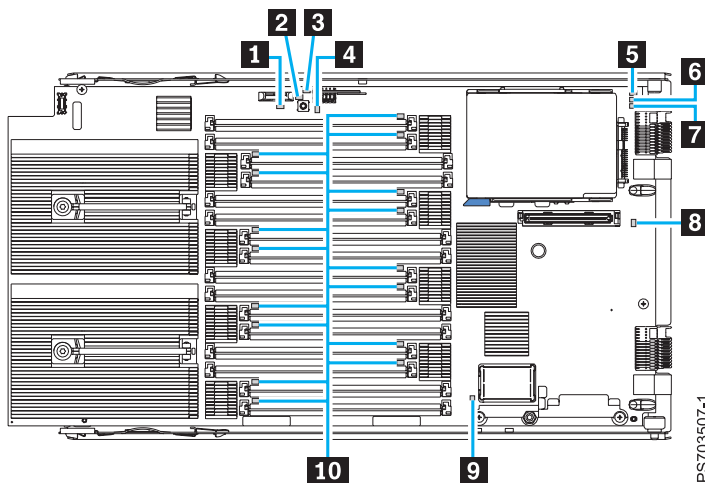
The following figure shows LEDs on the PS703 blade server.

Figure 12. LED locations on the system board of the PS703 blade server

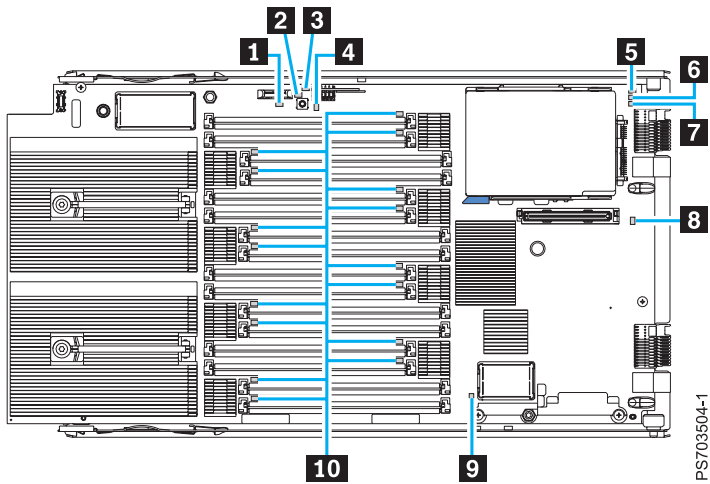
The following figure shows LEDs on the base system board of the PS704 blade server.

Figure 13. LED locations on the base system board of the PS704 blade server

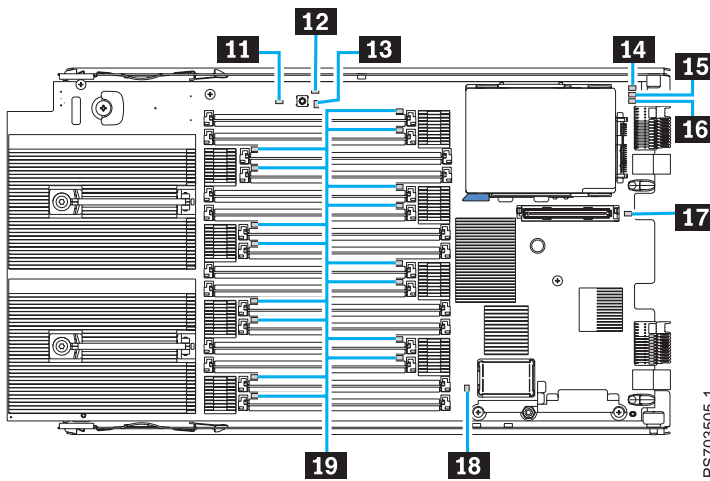
The following figure shows LEDs on the expansion-unit board of the PS704 blade server.

Figure 14. LED locations on the board of the PS704 expansion unit

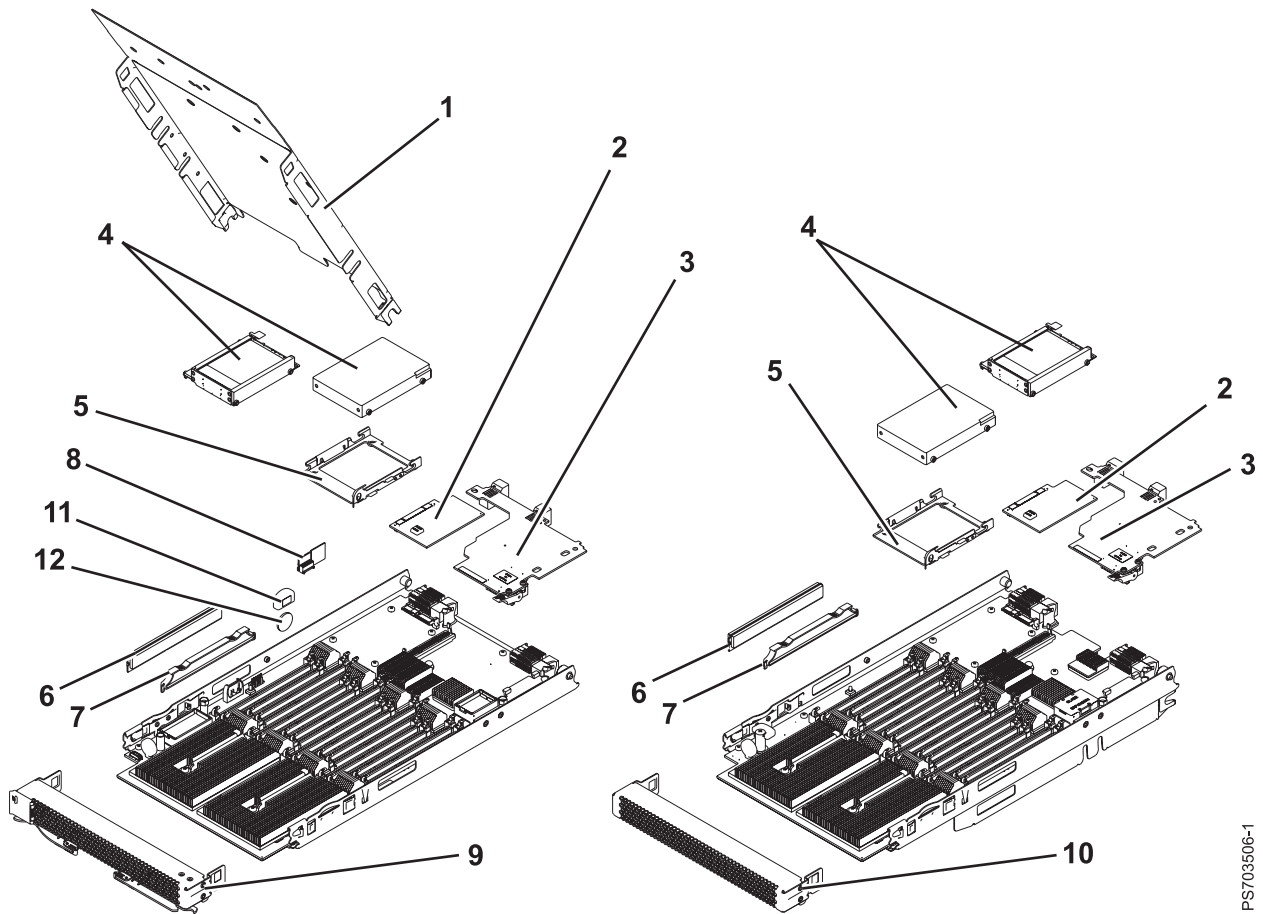
Figure 15 shows replaceable components that are available for the PS703 and PS704 blade server.

Figure 15. Parts illustration, type 7891. PS703 and PS704 with cover.

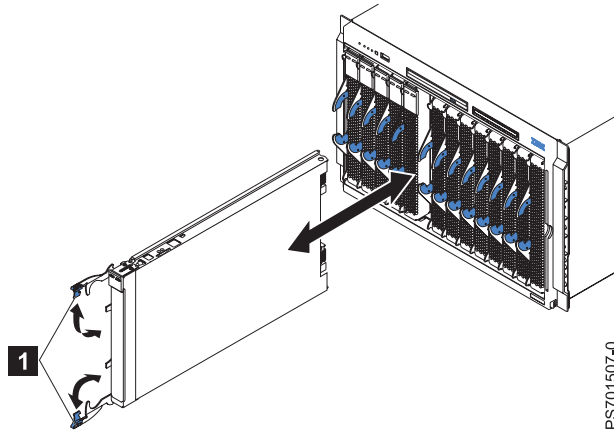
Figure 16. Removing the blade server from the BladeCenter unit

4. Wait at least 30 seconds for the hard disk drive to stop spinning.
5. Open the two release handles, as shown by **1** in Figure 16. The blade server moves out of the bay approximately 0.6 cm (0.25 inch).

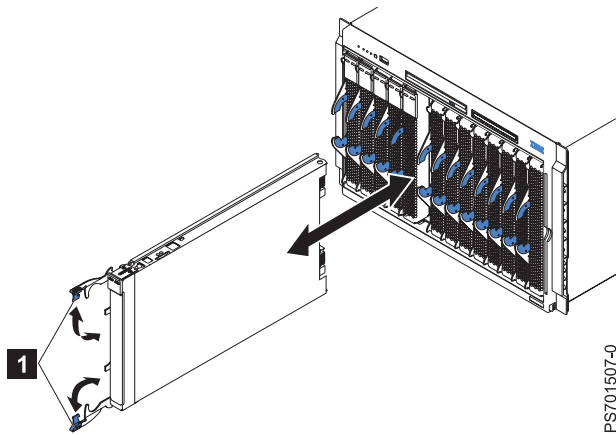
Figure 17. Installing the blade server in a BladeCenter unit

5. Verify that the release handles on the blade server are in the open position (perpendicular to the blade server, as shown in **1** in Figure 17 on page 232).

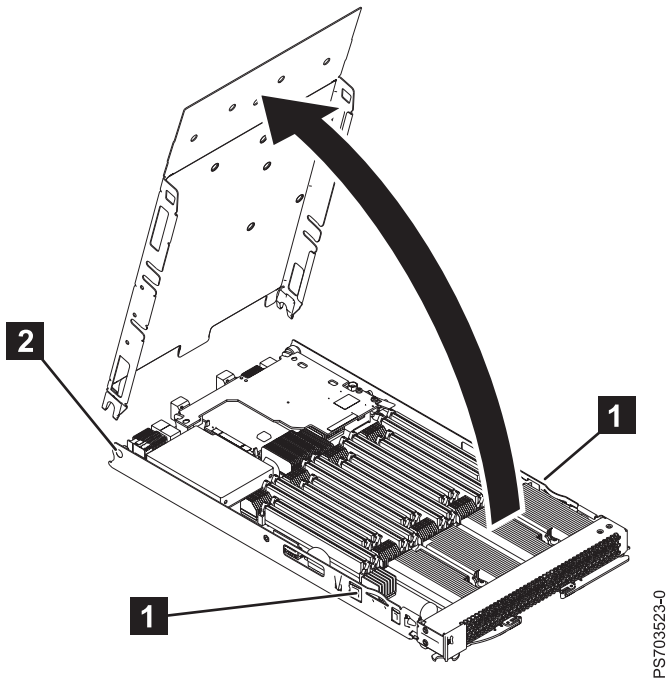
Figure 18. Removing the cover from a PS703 blade server

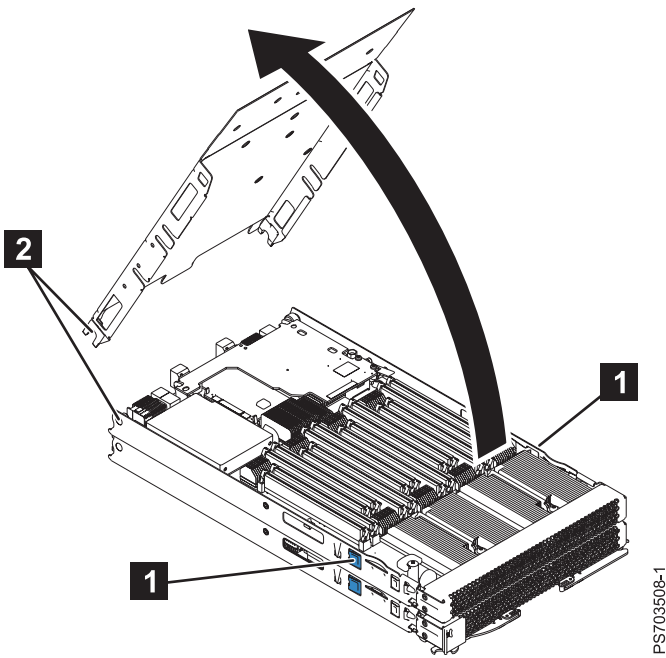
Figure 19. Removing the cover from a PS704 blade server

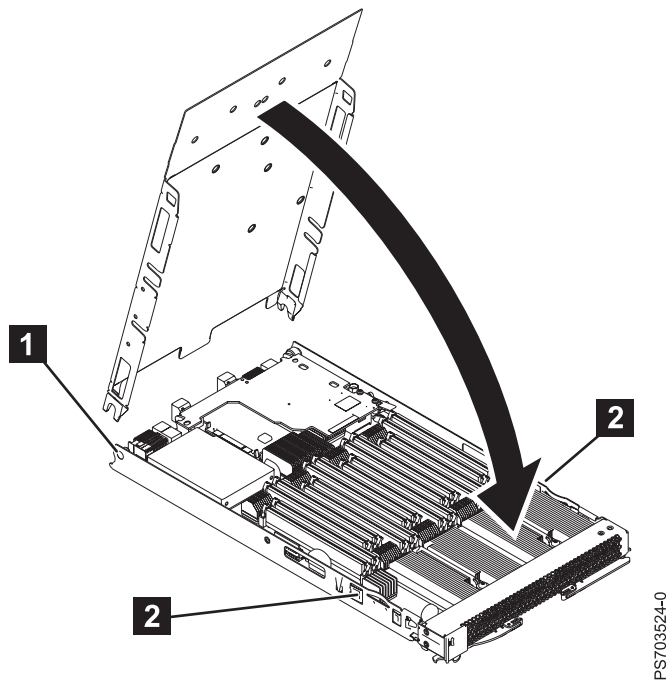
Figure 20. Installing the cover for a PS703 blade server

1. Read the Safety topic and the "Installation guidelines" on page 229.
2. Lower the cover so that the slots at the rear slide down onto the pins (**1** in Figure 20 on page 235) at the rear of the blade server. Before you close the cover, verify that all components are installed and seated correctly and that you have not left loose tools or parts inside the blade server.
3. Pivot the cover to the closed position until the releases (**2**) click into place in the cover.
4. Install the blade server into the BladeCenter unit. See "Installing the blade server in a BladeCenter unit" on page 232.

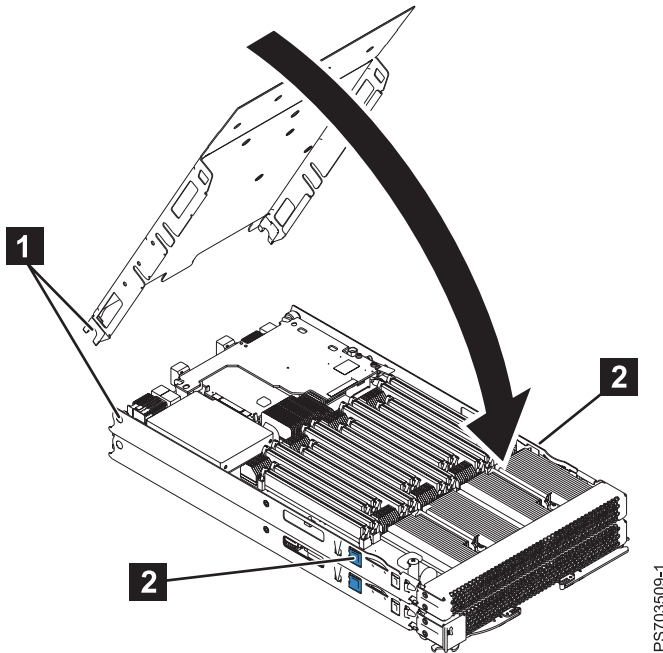
Figure 21. Installing the cover for a PS704 blade server

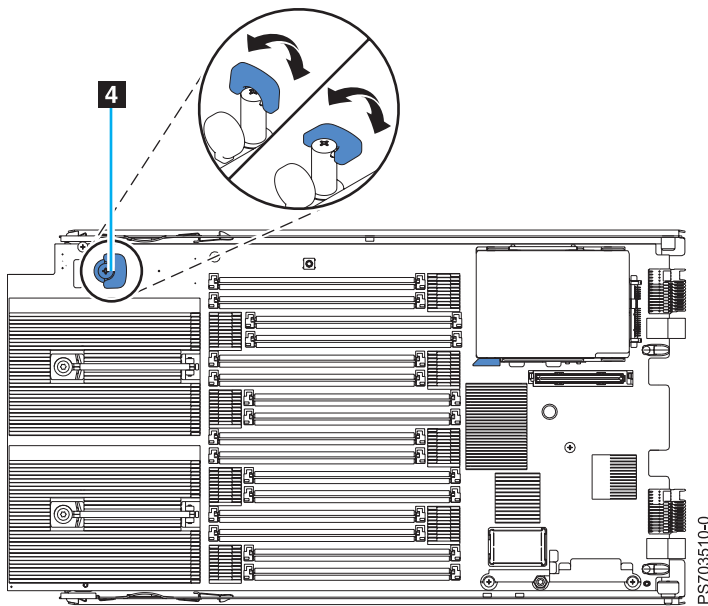
5. Use your thumb to back out the expansion blade retention thumb screw (**4**) by rotating the screw counterclockwise until the connection between the expansion unit and the base unit is loose and the expansion unit is fully separated from the base unit.

Figure 22. Removing the expansion unit

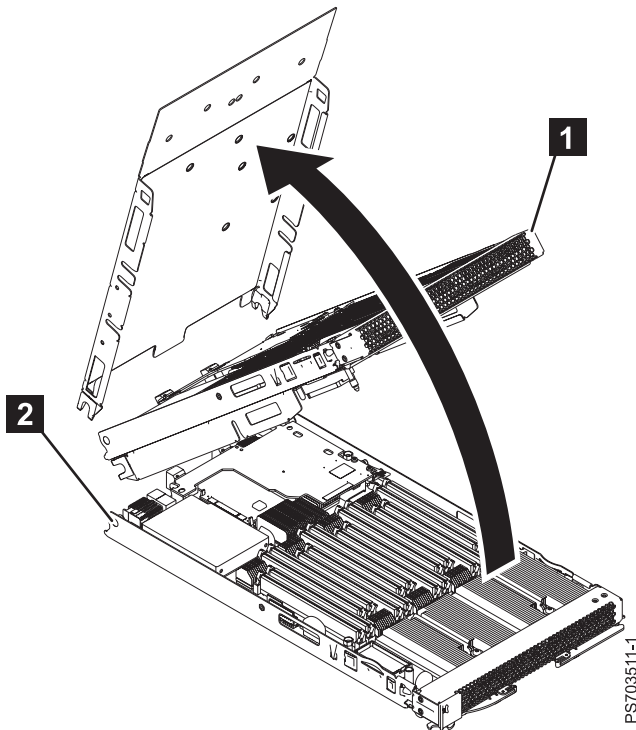
6. Pivot the expansion unit (**1** in Figure 23 on page 238) up on the cover pins of the base unit (**2**).

Figure 23. Removing the expansion unit

7. Lift the expansion unit (**1** in Figure 23) from the blade-server base unit and lay it on a flat, static-protective surface.
8. If you are replacing the expansion unit with a new expansion unit, see “Replacing the expansion unit in a PS704 blade server.” If you are removing the expansion unit as part of another procedure, return to that procedure now.
9. If you are instructed to return the expansion unit, follow all packaging instructions, and use any packaging materials for shipping that are supplied to you.

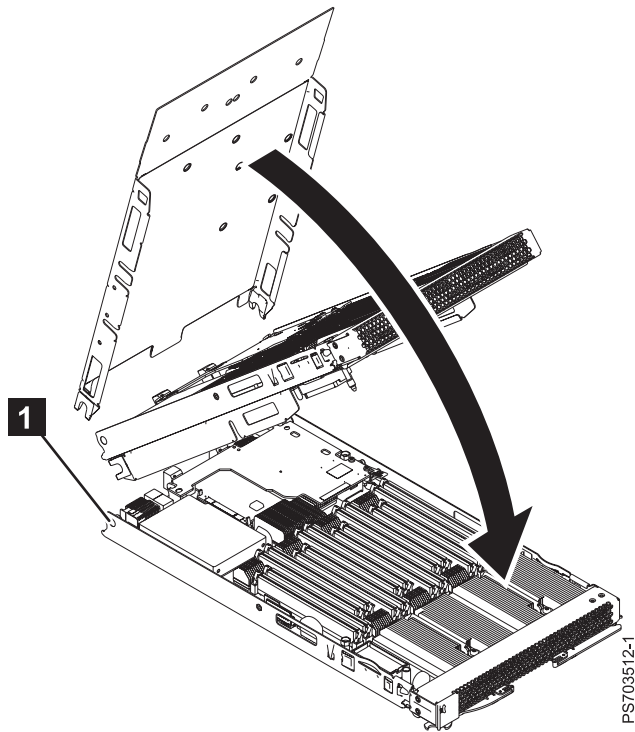
1. Lift the expansion unit above the blade server base unit and engage the circular pivot bearings onto the cover pins (as shown by **1** in Figure 24 on page 239) of the base unit.
The expansion unit of the PS704 blade server fits on top of the PS704 base unit, with the DIMM slots and expansion card slots on top.

Figure 24. Replacing the expansion unit

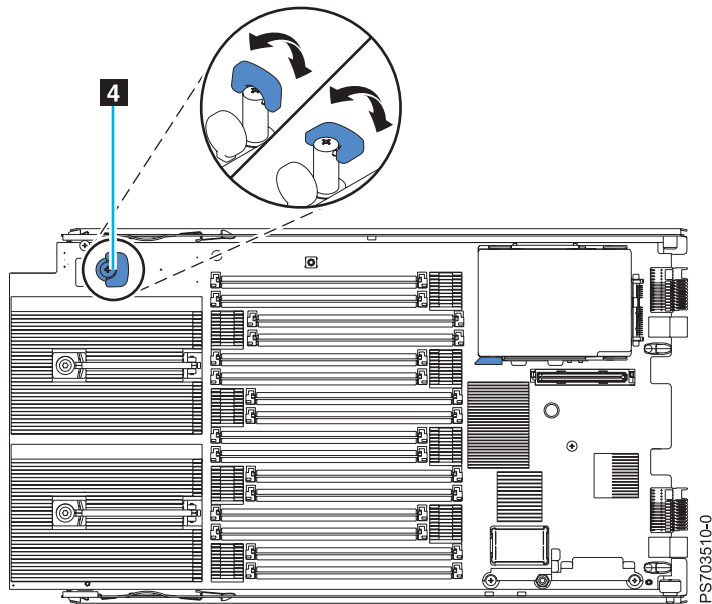
2. Pivot the expansion unit on the cover pins of the PS704 base unit and lower the expansion unit until it lies flat on the PS704 base unit.
3. To access the expansion-blade retention thumb screw, see **4** in Figure 25.

Figure 25. Expansion blade retention screw

4. Lift the wing on the expansion-blade retention thumb screw as shown in the preceding figure.
5. Tighten the thumb screw (**4**) by rotating the screw clockwise until the connection between the expansion unit and the PS704 base unit is secure. Stop tightening when firm resistance is detected. Ensure that the thumb screw wing is down.

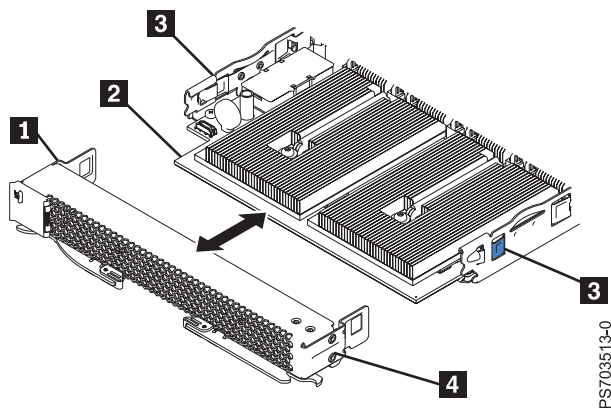
Figure 26. Removing the bezel assembly

5. Press the cover-assembly release (as shown by **3** in Figure 26 on page 240) on each side of the blade server and pull the bezel assembly (**4**) away from the blade server approximately 1.2 cm (0.5 inch).
6. If you are servicing a base unit and not an expansion unit, disconnect the control-panel (**1**) from the control-panel connector (**2**).
7. Pull the bezel assembly away from the blade server.
8. If you are instructed to return the bezel assembly, follow all packaging instructions, and use any packaging materials for shipping that are supplied to you.

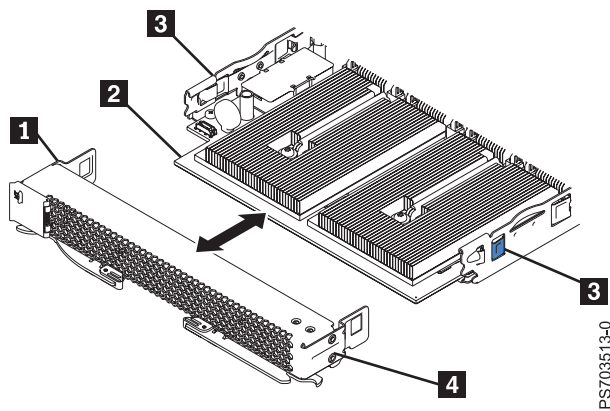
Figure 27. Installing the bezel assembly

1. If you are servicing a base unit and not an expansion unit, connect the control-panel cable (**1** in Figure 27) to the control-panel connector (**2**) on the system board.
2. Carefully slide the bezel assembly (**4**) onto the blade server until the two bezel-assembly releases (**3**) click into place in the bezel assembly.
3. Install and close the blade server cover. See “Installing and closing the blade server cover” on page 235.

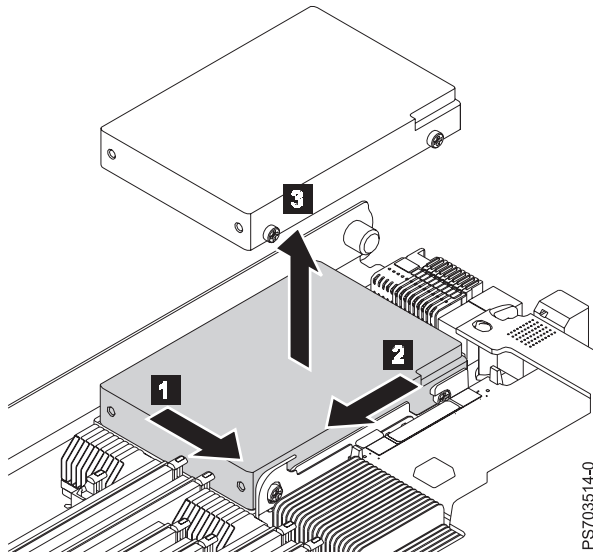
Figure 28. Removing a hard-disk drive

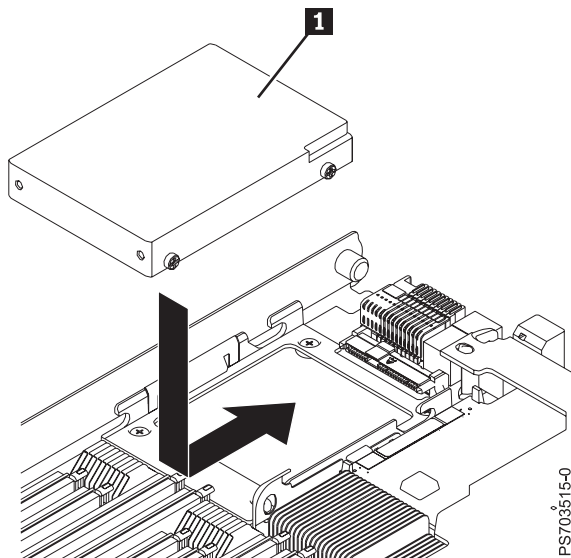
Figure 29 shows how to install the hard-disk drive.

Figure 29. Installing a hard-disk drive

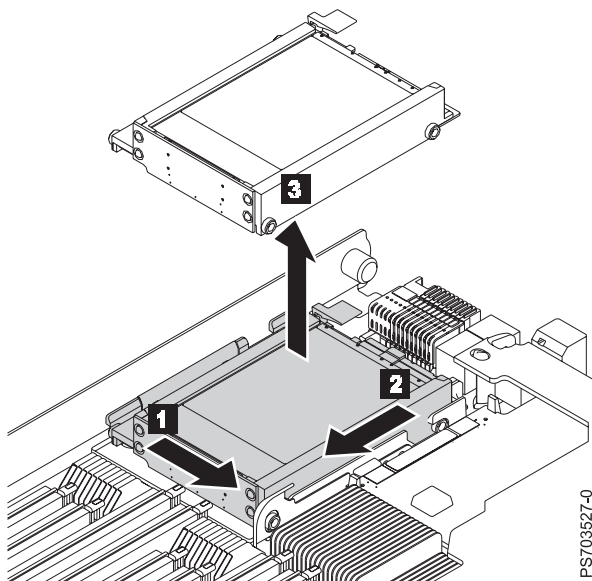
Figure 30. Removing an SSD carrier

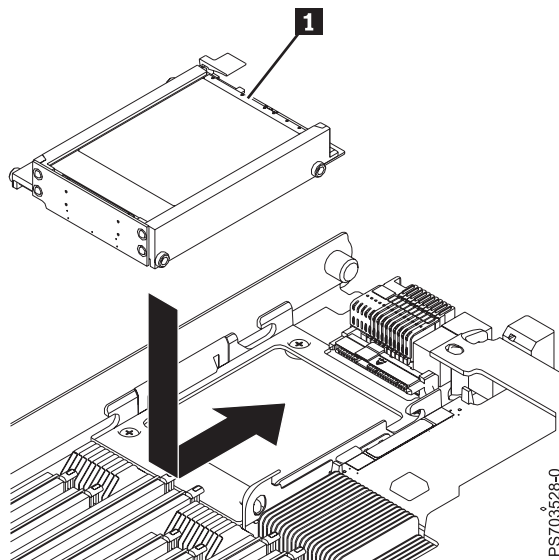
Figure 31 shows how to install the disk drive.

Figure 31. Replacing an SSD carrier

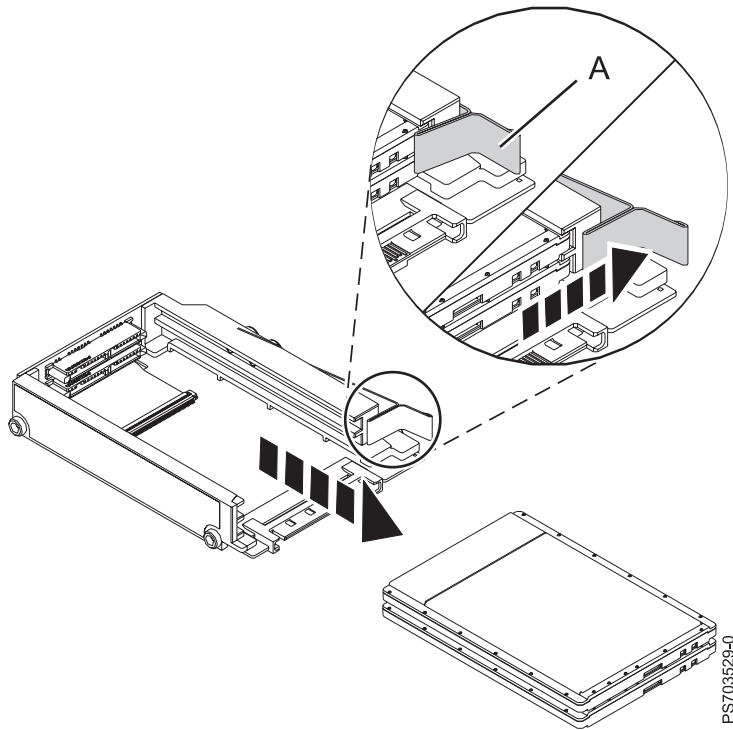
Figure 32. Removing a drive

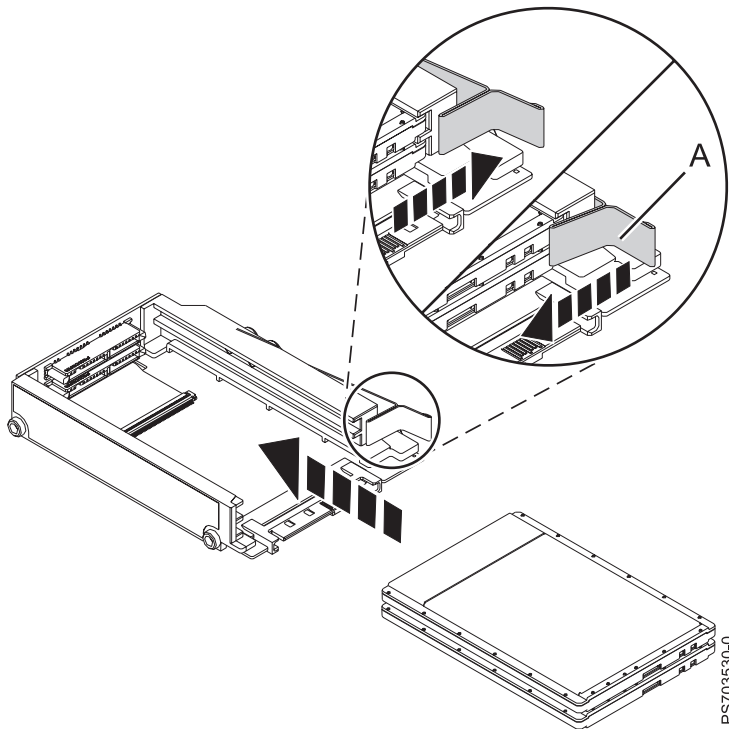
Figure 33 shows how to install the disk drive.

Figure 33. Installing an SSD

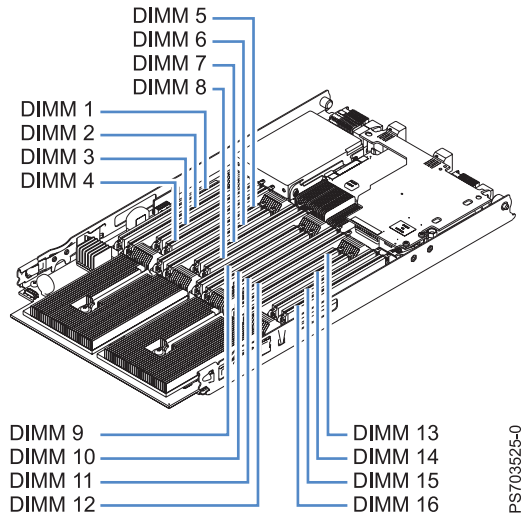
Figure 34. DIMM connectors for the PS703

5. Locate the DIMM connector that contains the DIMM being replaced.

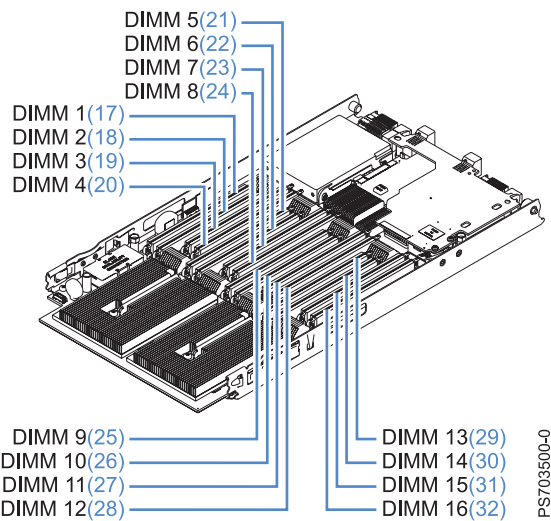
Figure 35. DIMM connectors for the PS704

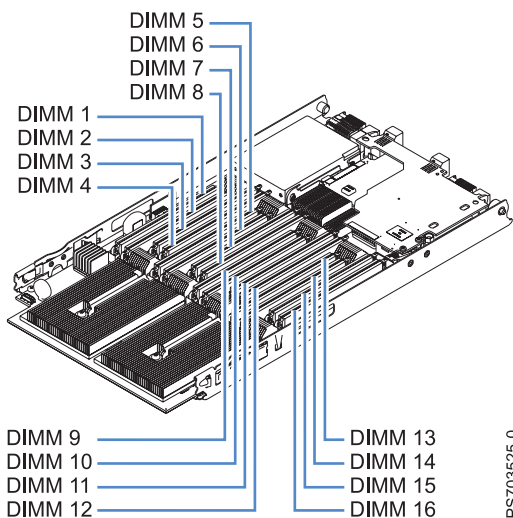
Table 38. Memory module combinations for the PS703 blade server

Figure 36. DIMM connectors for the PS703

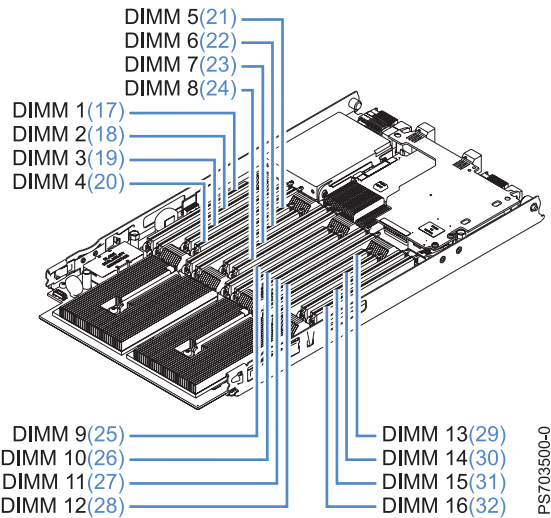
Table 39. Memory module combinations for the PS704 blade server

Figure 37. DIMM connectors for the PS704

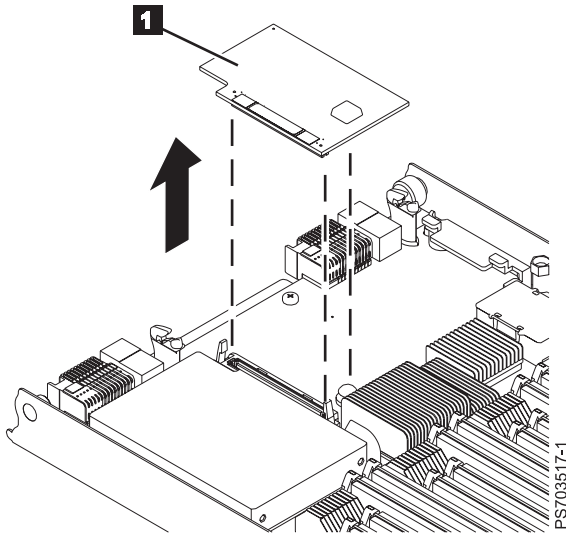
You can remove a CIOv form-factor expansion card from the CIOv connector from a PS703 blade server, or from either the base unit or the expansion unit of a PS704 blade server.

Figure 38. Removing a CIOv form factor expansion card from the CIOv connector

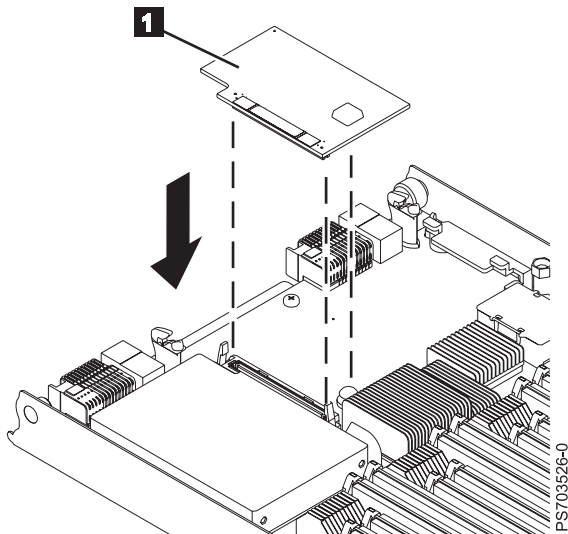
You can install a CIOv form-factor expansion card on the CIOv connector to expand the I/O capabilities of the blade server.

Figure 39. Installing a CIOv form-factor expansion card on the CIOv connector

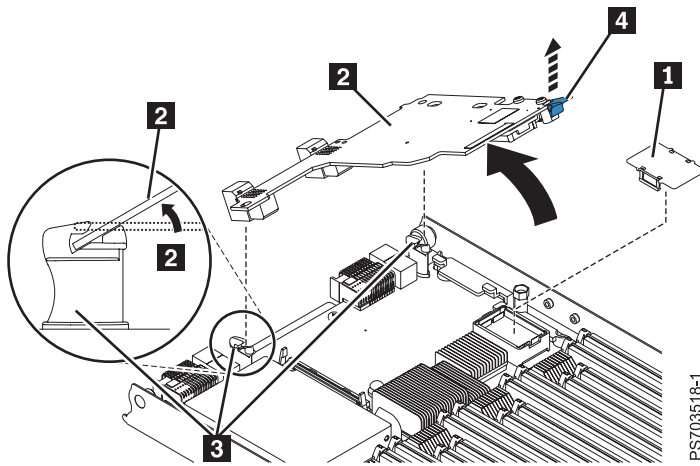
Complete this procedure to remove a combination-form-factor (CFFh) expansion card from a PS703 blade server, or from either the base unit or the expansion unit of a PS704 blade server.

Figure 40. Removing a combination-form-factor expansion card

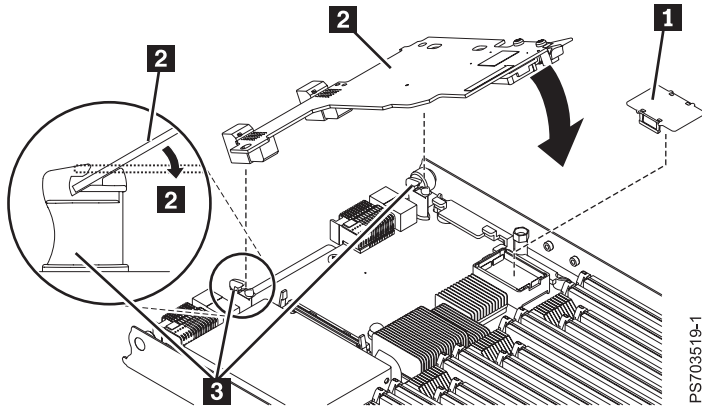
Install a combination-form-factor (CFFh) expansion card to expand the I/O capabilities of the blade server.

Figure 41. Installing a combination-form-factor expansion card

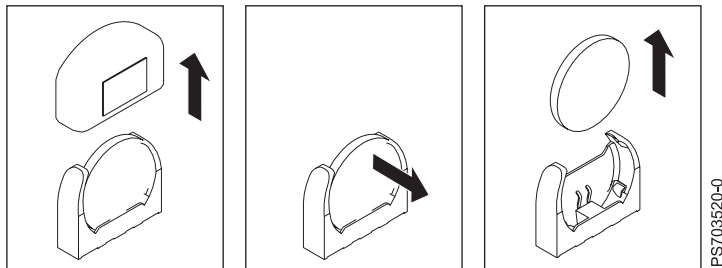
Figure 42. Removing the battery

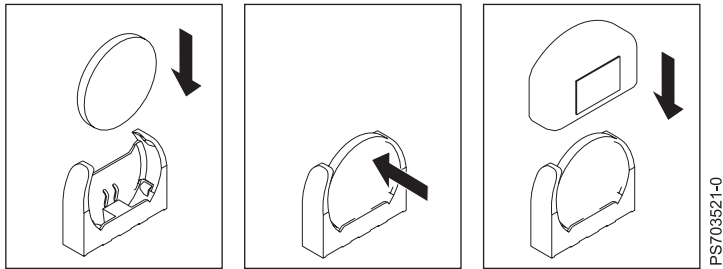
Figure 43. Installing the battery

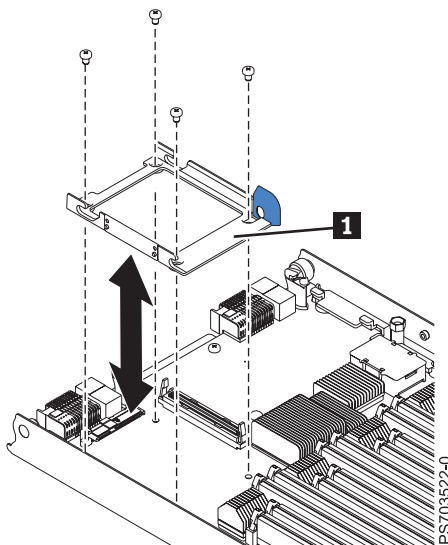
Figure 44. Removing the disk drive tray

5. Remove the disk drive if one is installed. See “Removing a hard-disk drive” on page 242.
6. Remove the four screws that secure the drive tray (**1** in Figure 44 on page 260) to the system board and remove the drive tray.

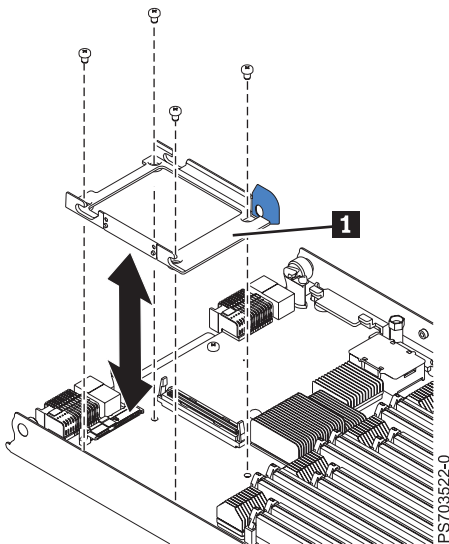
Figure 45. Installing the disk drive tray

1. Place the drive tray (**1** in Figure 45) into position on the system board and install the four screws to secure it.
2. Install the disk drive that was removed from the drive tray. See “Installing a hard-disk drive” on page 243 for instructions.
3. Install and close the blade server cover. See “Installing and closing the blade server cover” on page 235.

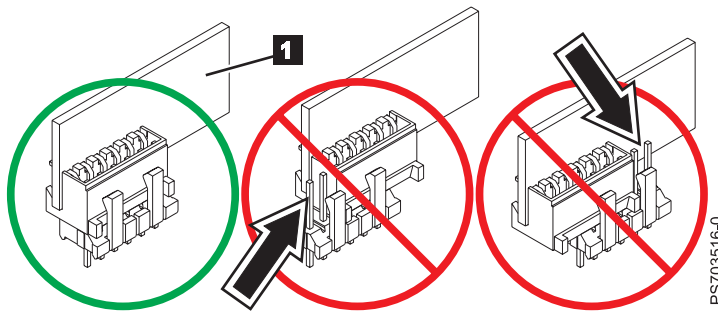
Figure 46. Removing the management card

To remove the management card, which is shown by **1** in Figure 46, complete the following steps:

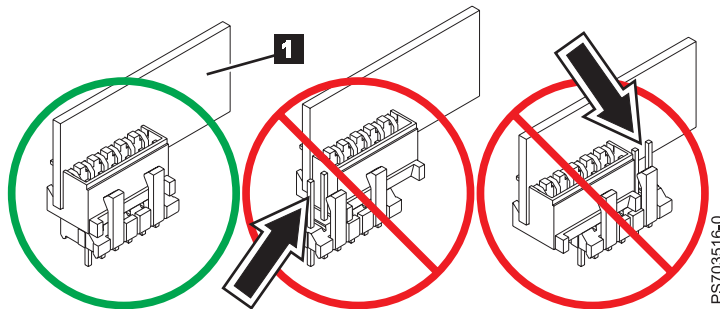
Figure 47. Installing the management card

To install the management card, which is shown by **1** in Figure 47, complete the following steps:
