Advanced Management Module Messages Guide

Thirteenth Edition (October 2013)

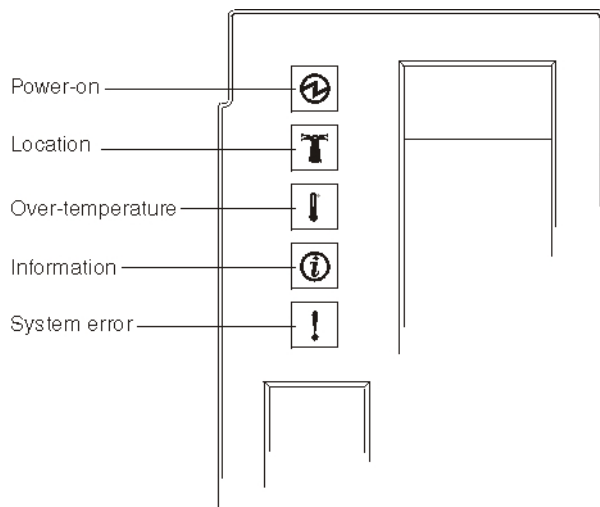
For example, on a BladeCenter S chassis, the following system LEDs are displayed on the media tray:

View the system LEDs remotely through the advanced management module Web interface. The main LED page shows the external LEDs on the chassis panels and the front panel. The internal blade LEDs are also available through a blade hyperlink from the LED page. This enables you to see the status of the internal LEDs on the blade server without having to turn off the blade server, remove it from the chassis, and activate the light path indications.

The chassis LEDs indicate the status of the components in the chassis. For example, if the error, information, temperature, or location LED is lit for a blade server, the same LED will be lit on the system LED panel for the chassis. The information and location LEDs can also be turned off remotely, but you might need to turn off the LED on the blade for the request to be accepted.

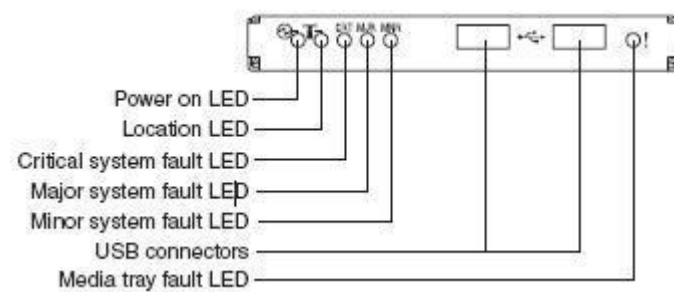
Light path diagnostic LEDs - BladeCenter T and BladeCenter HT chassis

The system LEDs are displayed on the media tray.

The following system LEDs are displayed:

Power-on
