Advanced Management Module Messages Guide

Eleventh Edition (May 2013)

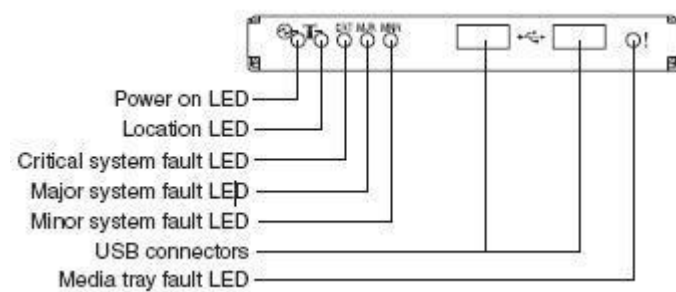
Light path diagnostic LEDs - BladeCenter T and BladeCenter HT chassis

The system LEDs are displayed on the media tray.

The following system LEDs are displayed:
