Brocade Fabric OS v6.3.0d

Release Notes v1.0

March 22, 2010

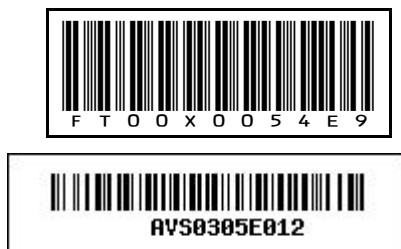
The switch serial number is provided on the serial number label, examples of which are shown here:

The serial number label is located as follows:

- Brocade 4100, 4900, and 7500/7500E — On the switch ID pull-out tab located inside the chassis on the port side on the left
- Brocade Encryption Switch, 300, 5000, 5100, and 5300 — On the switch ID pull-out tab located on the bottom of the port side of the switch
- Brocade 7600 — On the bottom of the chassis
- Brocade 7800 — On the pull-out tab on the front left side of the chassis underneath the serial console and Ethernet connection and on the bottom of the switch in a well on the left side underneath (looking from front)
