iSeries

Analyze Hardware Problems (Problem Analysis and Isolation)

Version 5 Release 3 Modification 2

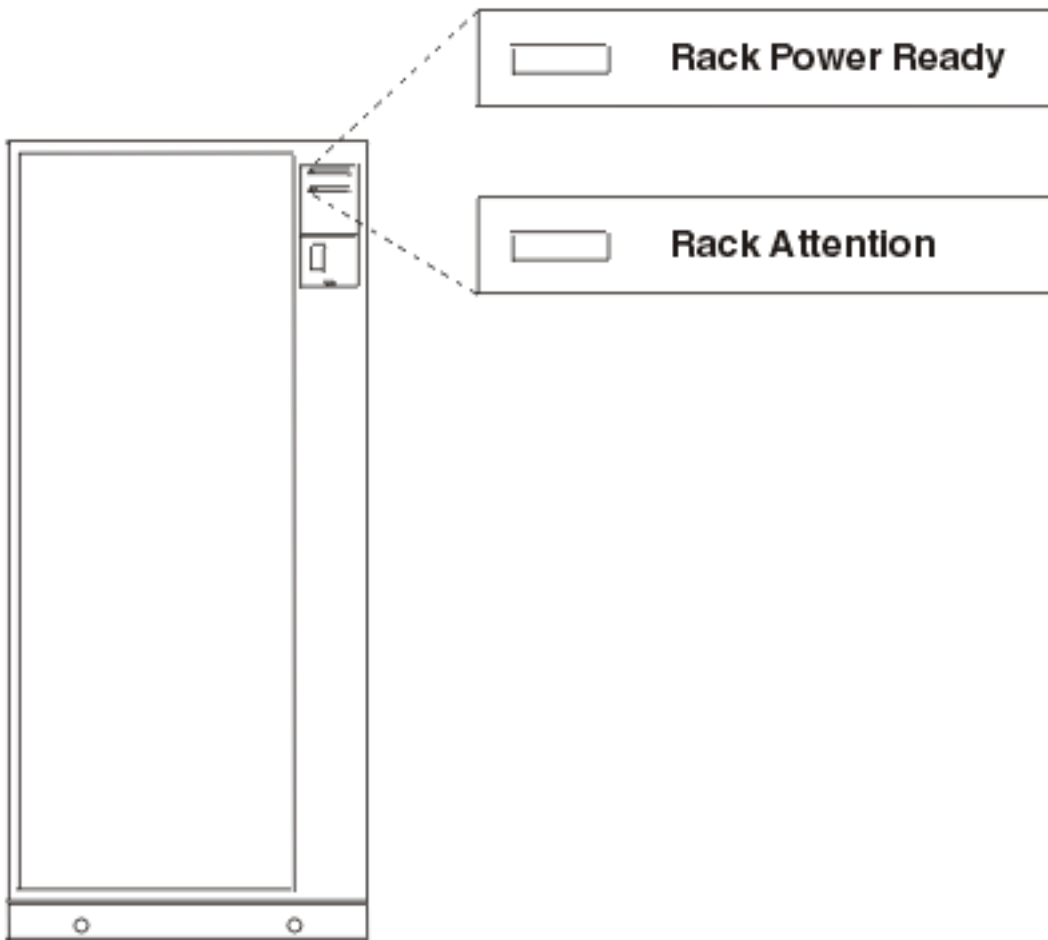
RV2A176-2

Note: Stage 2 frames (FC 9309) have a rack attention light on the frame control panel.

Figure 1. Stage 2 frame (FC 9309) rack attention light

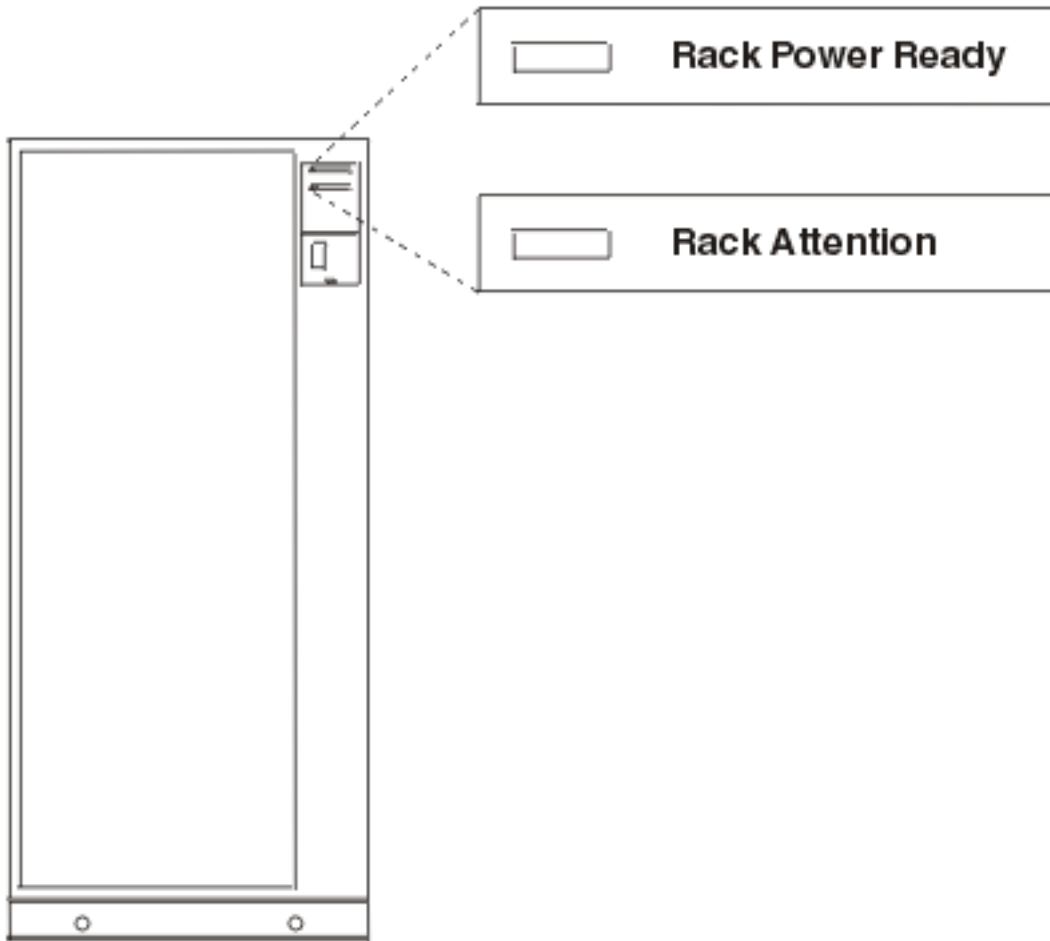
FV2A176-2

1. Does the frame that cannot become powered on contain a 3490 or a 3590 tape unit?
 - **No:** Continue with the next step.
 - **Yes:** Go to the service information for the specific tape unit to analyze the problem.
This ends the procedure.
2. Is the secondary frame a Stage 2 frame (FC 9309)?
Note: Stage 2 frames (FC 9309) have a Rack Attention light on the frame control panel.

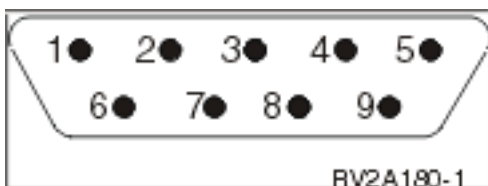
- a. Follow the SPCN frame-to-frame cable back to the preceding frame in the string.
- b. Disconnect the SPCN cable from J16 on the PCC, AC module, or SPCN card.
- c. Connect the negative lead of a multimeter to the frame ground.
- d. Connect the positive lead of a multimeter to pin 2 of J16.

Note: Use an insulated probe or jumper when performing the voltage readings.
- e. Note the voltage reading on pin 2.
- f. Move the positive lead of the multimeter to pin 3 of J16.
- g. Note the voltage reading on pin 3.

Is the voltage on both pin 2 and pin 3 from 1.5 V dc to 5.5 V dc?

- **No:** Exchange the power control compartment, AC module, or SPCN card (BKSPCN or TWRCARD) from which you disconnected the SPCN cable earlier in this step.

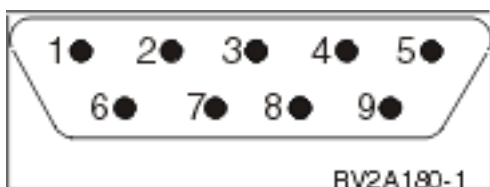
49. Perform the following:
- Power off the system.
 - Disconnect the SPCN frame-to-frame cable from J15 on the AC module or SPCN card of the first frame or unit that cannot become powered on.
 - Connect the negative lead of a multimeter to the system frame ground.
 - Connect the positive lead of the multimeter to pin 2 of the SPCN cable.
- Note:** Use an insulated probe or jumper when performing the voltage readings.
- Note the voltage reading on pin 2.
 - Move the positive lead of the multimeter to pin 3 of the SPCN cable.
 - Note the voltage reading on pin 3.

Is the voltage on both pin 2 and pin 3 from 1.5 V dc to 5.5 V dc?

- **No:** Continue with the next step.
- **Yes:** Exchange the following FRUs, one at a time. See the Remove and replace procedures topic, or the *Migrated Expansion Tower Problem Analysis, Repair and Parts* manual on the V5R1 Supplemental Manuals web site

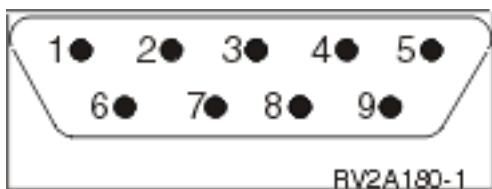
- c. Connect the negative lead of a multimeter to the system frame ground.
 - d. Connect the positive lead of the multimeter to pin 2 of the SPCN cable.
Note: Use an insulated probe or jumper when performing the voltage readings.

- e. Note the voltage reading on pin 2.
 - f. Move the positive lead of the multimeter to pin 3 of the SPCN cable.
 - g. Note the voltage reading on pin 3.

Is the voltage on both pin 2 and pin 3 from 1.5 V dc to 5.5 V dc?

- **Yes:** Exchange the following FRUs, one at a time (see Remove and replace procedures).
 - SPCN card (see symbolic FRU TWRCARD) in the failing unit.
 - SPCN card (see symbolic FRU TWRCARD) in the preceding unit in the unit string.
 - SPCN frame-to-frame cable.**This ends the procedure.**
 - **No:** Continue with the next step.
26. Perform the following:
 - a. Follow the SPCN frame-to-frame cable back to the preceding unit in the string.
 - b. Disconnect the SPCN cable from J16 connector.
 - c. Connect the negative lead of a multimeter to the system frame ground.

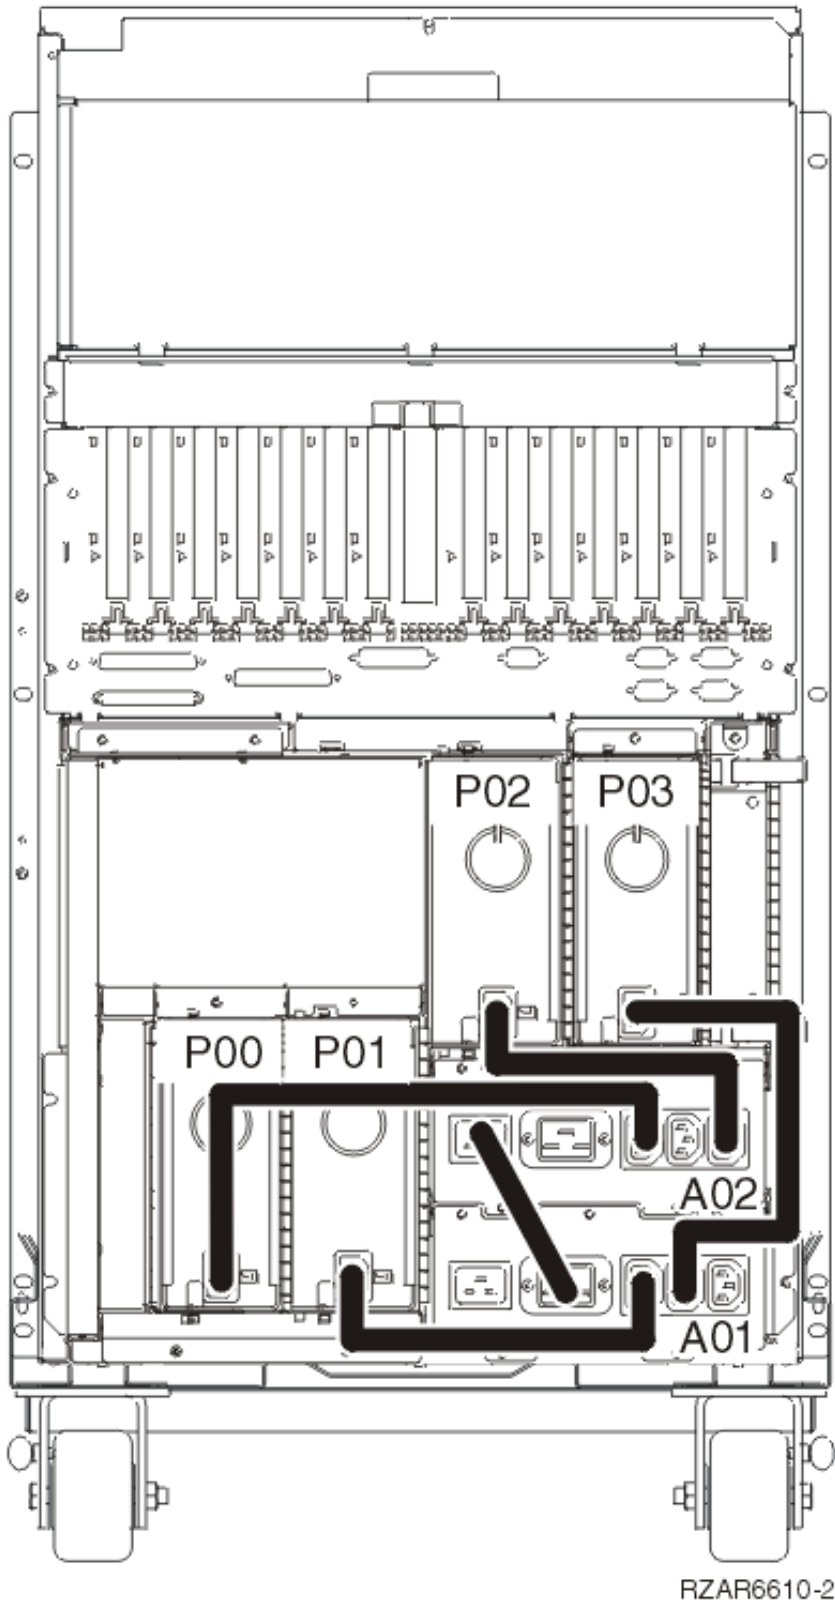
- (SRC 1xxx 1500): the ac jumper cord connected to P00 and the AC module.
 - (SRC 1xxx 1510): the ac jumper cord connected to P01 and the AC module.
 - (SRC 1xxx 1520): the ac jumper cord connected to P02 and the AC module.

- (SRC 1xxx 1530): the ac jumper cord connected to P03 and the AC module.
- Figure 1. Dual line cord drawing for FC 5094 and FC 9094

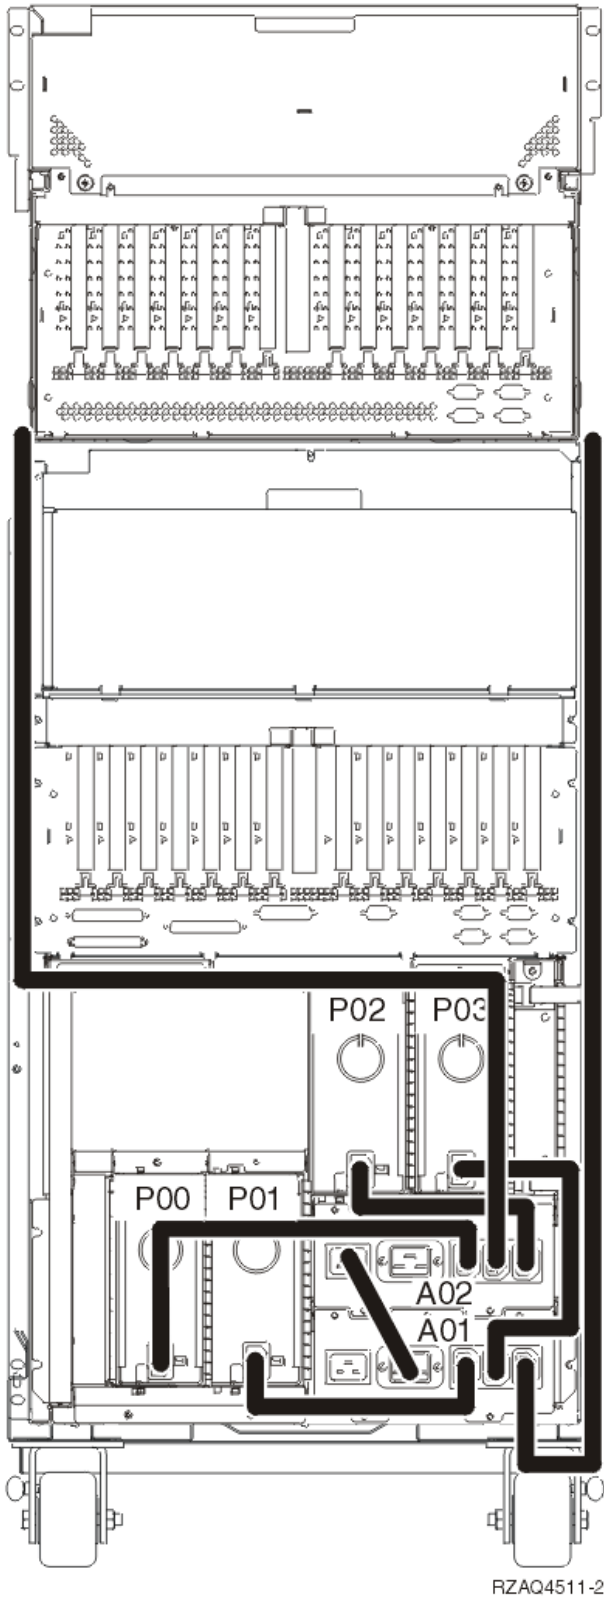
Figure 2. Dual line cord drawing for an FC 5078, FC 0578, FC 5088, or FC 0588 installed on an FC 5094 or FC 9094

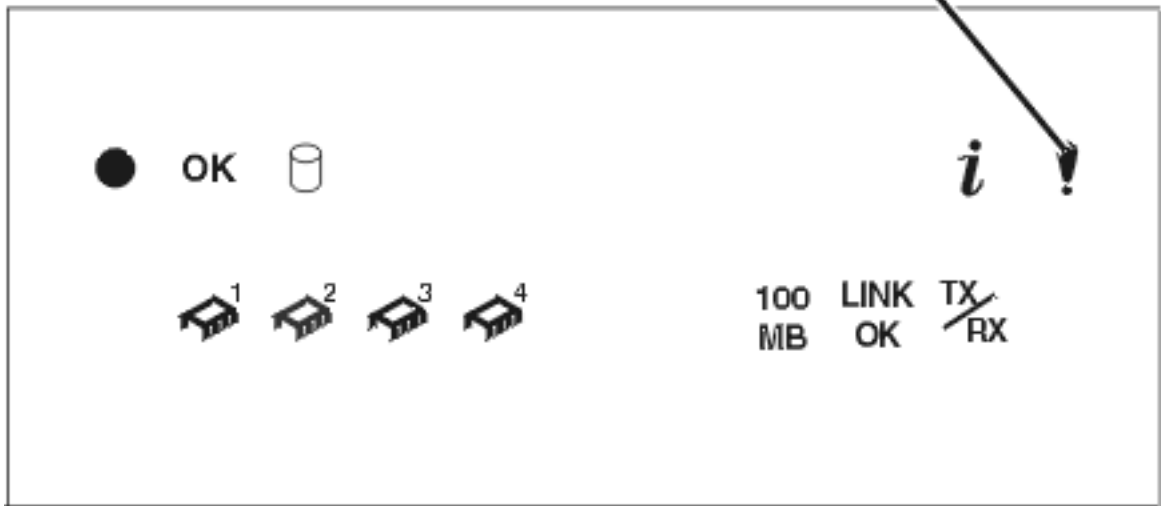
RZAQ4802-0

Figure 1. Integrated xSeries^(R) Server (IXS) - Control Panel

System error light.

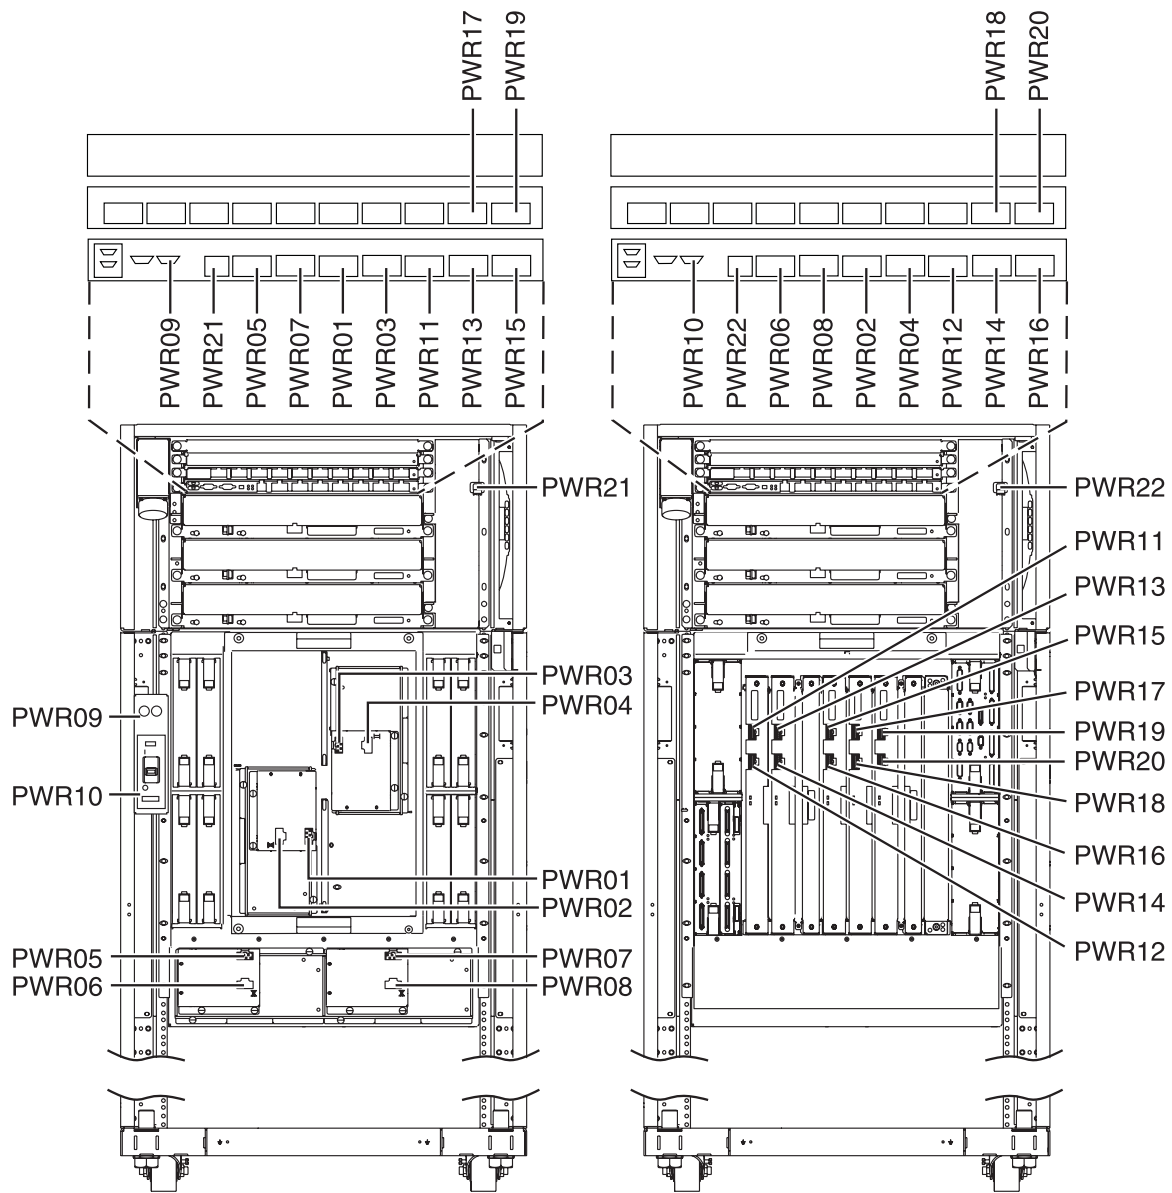
RZAR6902-5

Figure 1. Part locations for power cables

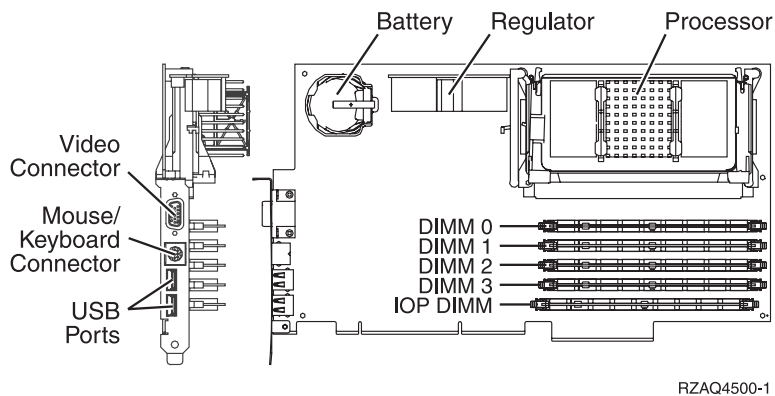
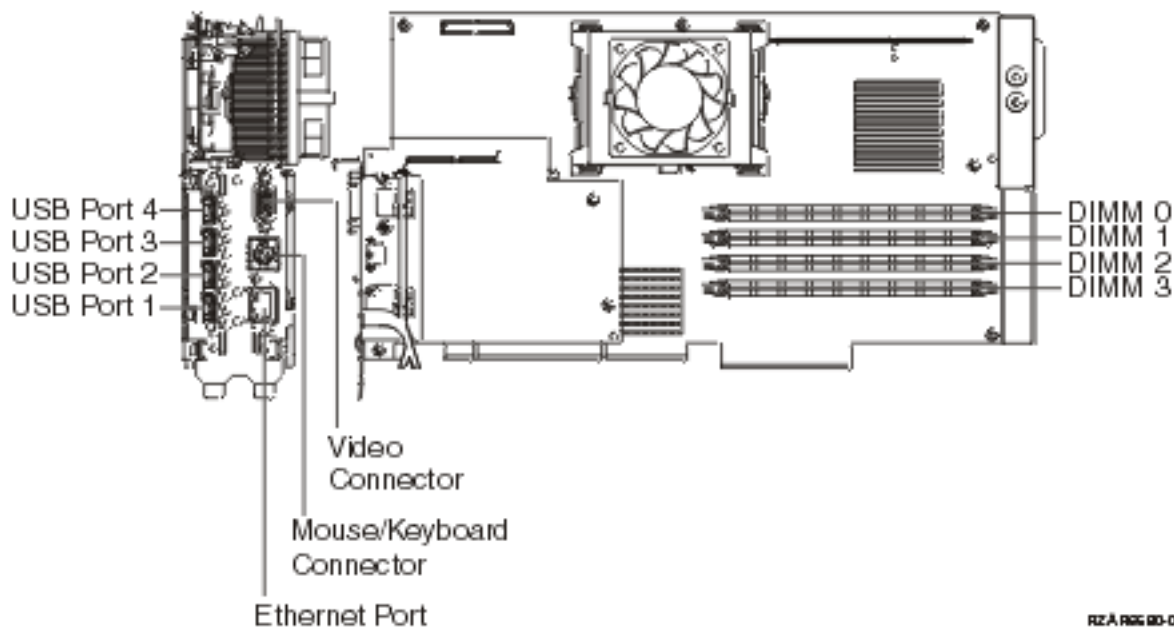
Figure 1. Locations of DIMM 0, DIMM 1, DIMM 2 and DIMM 3 on 2890 Integrated xSeries Server (IXS) card.

Figure 2. Locations of DIMM 0, DIMM 1, DIMM 2 and DIMM 3 on 2892 Integrated xSeries Server (IXS) card.

In both figures, the **first** DIMM from the top of the IXS card (DIMM 0) is the failing item. To determine the part number, go to symbolic FRU MEMORY.
This ends the procedure.

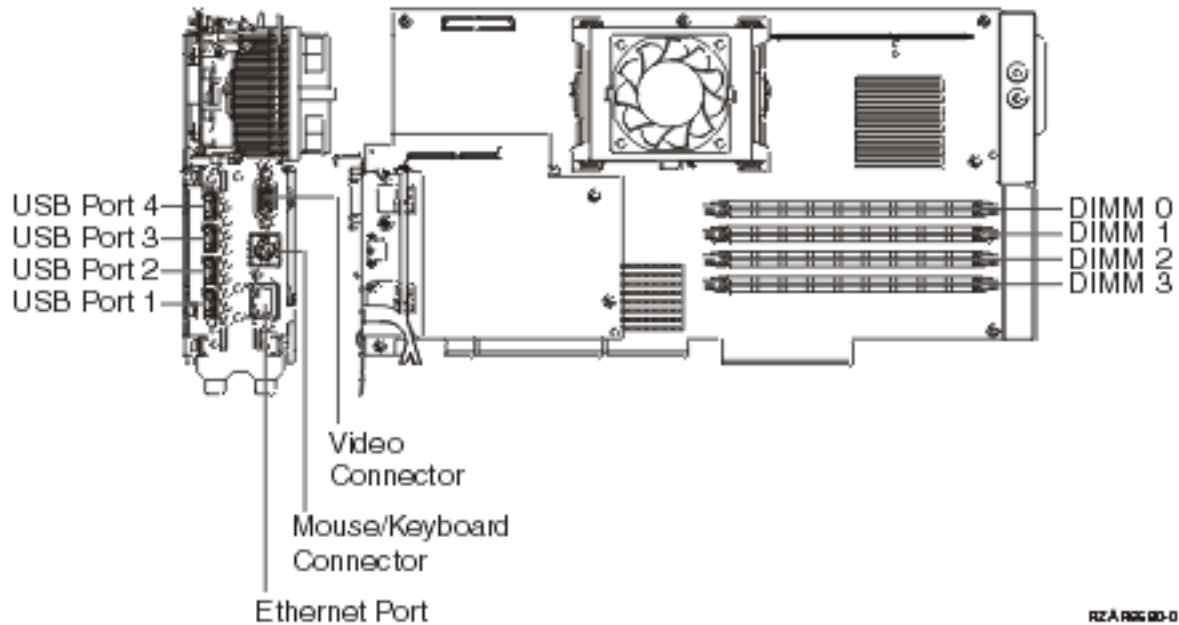
Figure 1. Locations of DIMM 0, DIMM 1, DIMM 2 and DIMM 3 on 2892 Integrated xSeries Server (IXS) card.

The **first** or **second** DIMM from the top (DIMM 0 or DIMM 1) of the IXS card is the failing item. To determine the part number, go to symbolic FRU MEMORY. **This ends the procedure.**

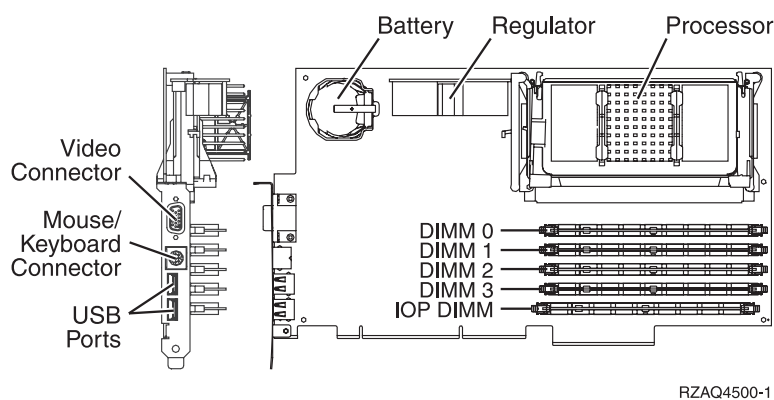
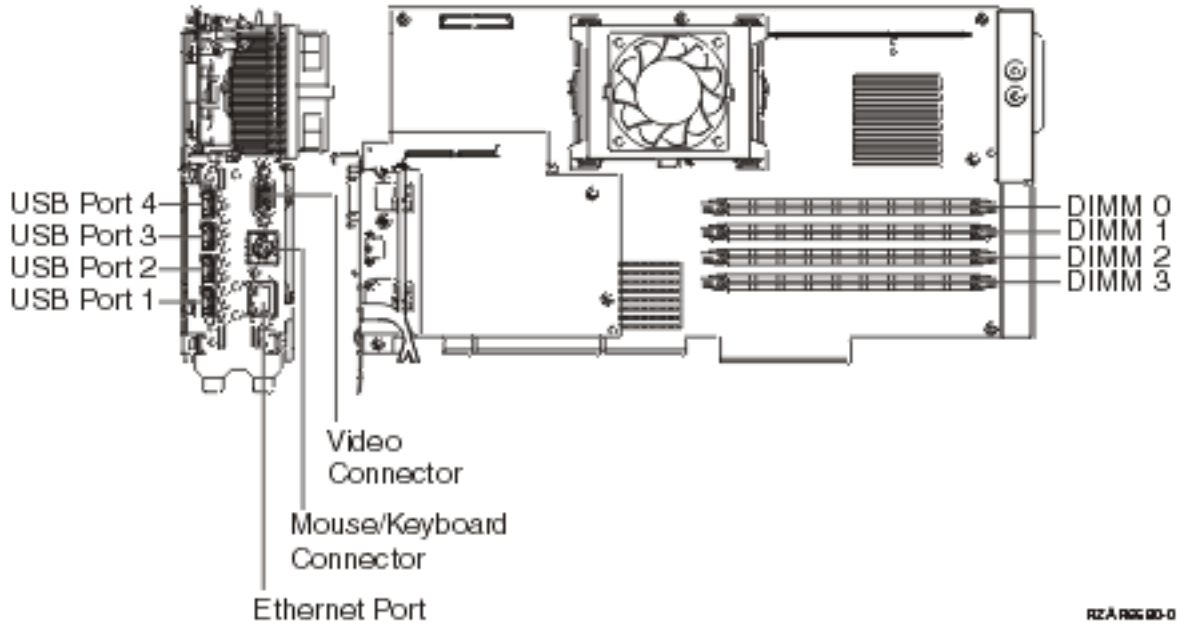
Figure 1. Locations of DIMM 0, DIMM 1, DIMM 2 and DIMM 3 on 2890 Integrated xSeries Server (IXS) card.

Figure 2. Locations of DIMM 0, DIMM 1, DIMM 2 and DIMM 3 on 2892 Integrated xSeries Server (IXS) card.

In both figures, the **second** DIMM from the top of the IXS card (DIMM 1) is the failing item. To determine the part number, go to symbolic FRU MEMORY. **This ends the procedure.**

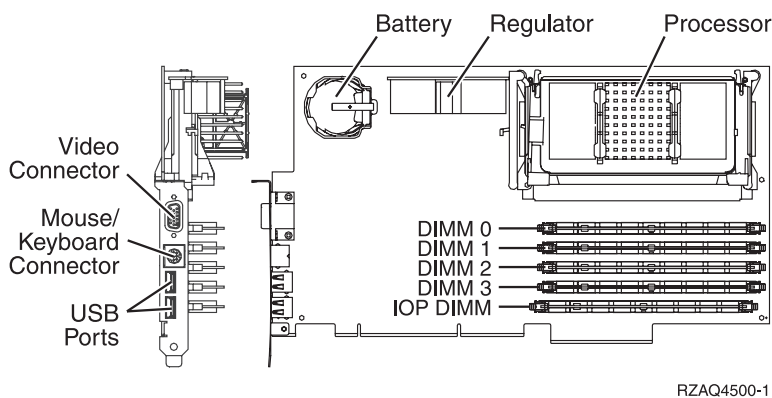
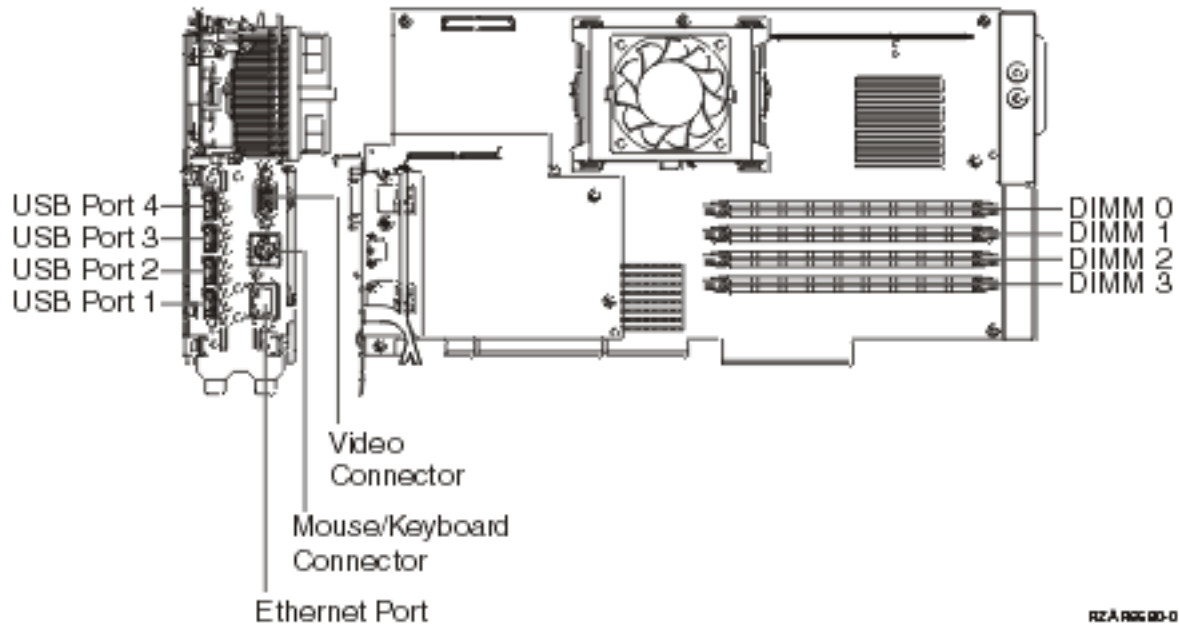
Figure 1. Locations of DIMM 0, DIMM 1, DIMM 2 and DIMM 3 on 2890 Integrated xSeries Server (IXS) card.

Figure 2. Locations of DIMM 0, DIMM 1, DIMM 2 and DIMM 3 on 2892 Integrated xSeries Server (IXS) card.

In both figures, the **third** DIMM from the top (DIMM 2) of the IXS card is the failing item. To determine the part number, go to symbolic FRU MEMORY.
This ends the procedure.

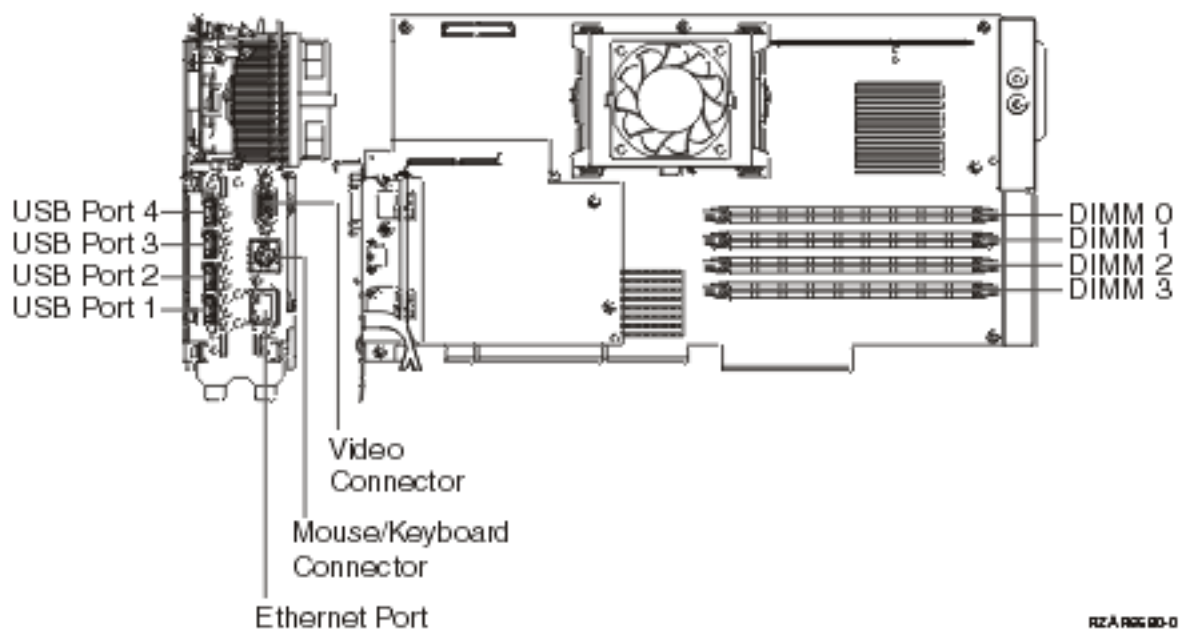
Figure 1. Locations of DIMM 0, DIMM 1, DIMM 2 and DIMM 3 on 2892 Integrated xSeries Server (IXS) card.

The **third** or **fourth** DIMM from the top (DIMM 0 or DIMM 1) of the IXS card is the failing item. To determine the part number, go to symbolic FRU MEMORY.
This ends the procedure.

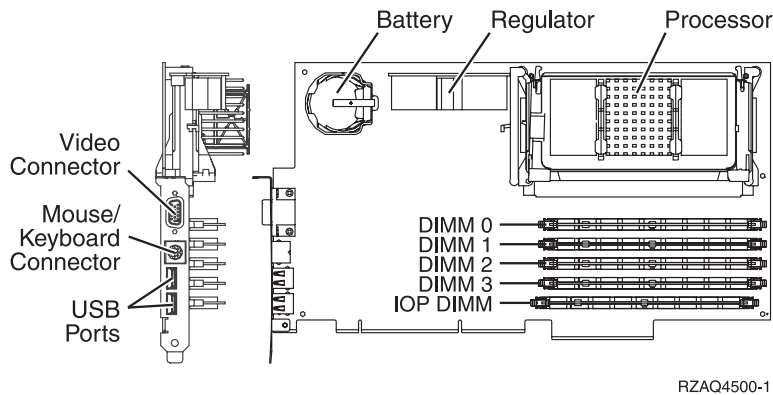
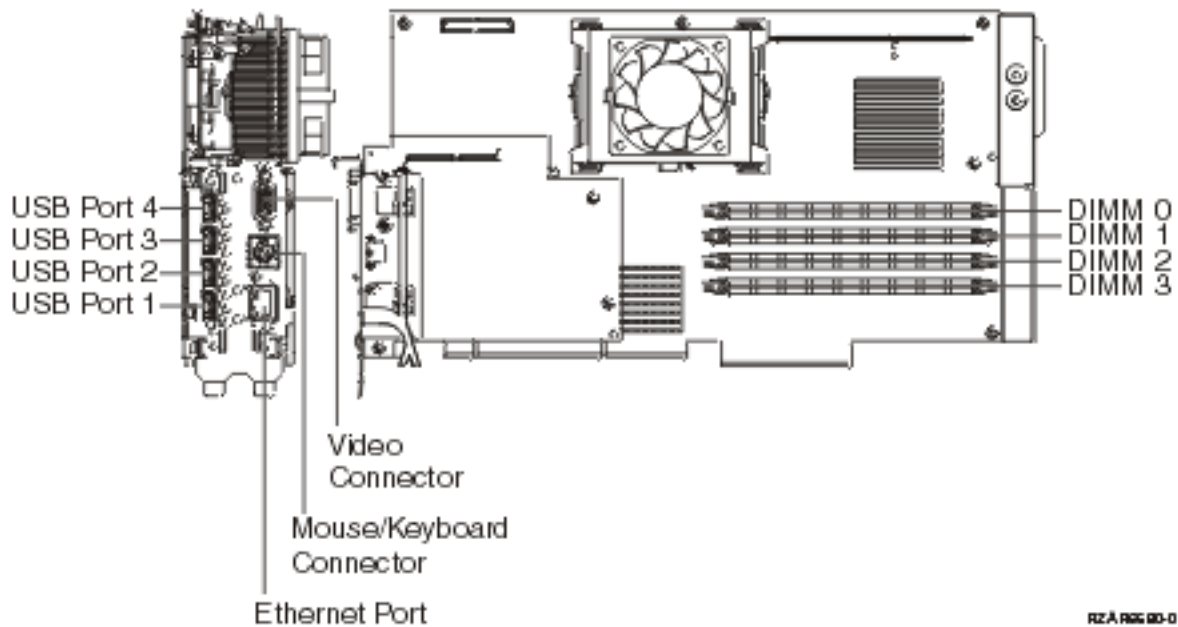
Figure 1. Locations of DIMM 0, DIMM 1, DIMM 2 and DIMM 3 on 2890 Integrated xSeries Server (IXS) card

Figure 2. Locations of DIMM 0, DIMM 1, DIMM 2 and DIMM 3 on 2892 Integrated xSeries Server (IXS) card

In both figures, the **fourth** DIMM from the top (DIMM 3) of the IXS card is the failing item. To determine the part number, go to symbolic FRU MEMORY.
This ends the procedure.

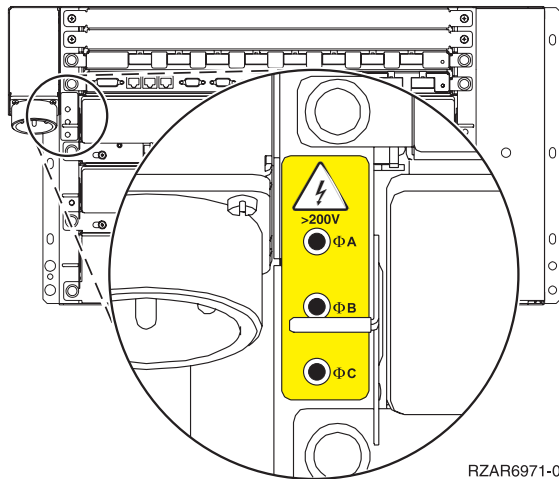
Figure 1. Measuring the ac voltage

- Phase A and phase B
- Phase B and phase C
- Phase C and phase A

Are all the readings greater than 180 V ac?

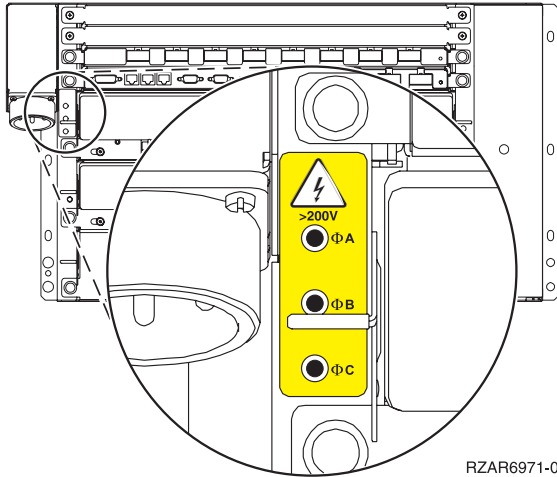
- a. Prepare a multimeter to measure up to 600 V ac.
 - b. Use the multimeter to measure the ac voltage at the following test points on the faceplate of the BPA that is referenced by the error code that sent you to this procedure:
Figure 1. Measuring the ac voltage

- Phase A and phase B
- Phase B and phase C
- Phase C and phase A

Are all the readings greater than 180 V ac?

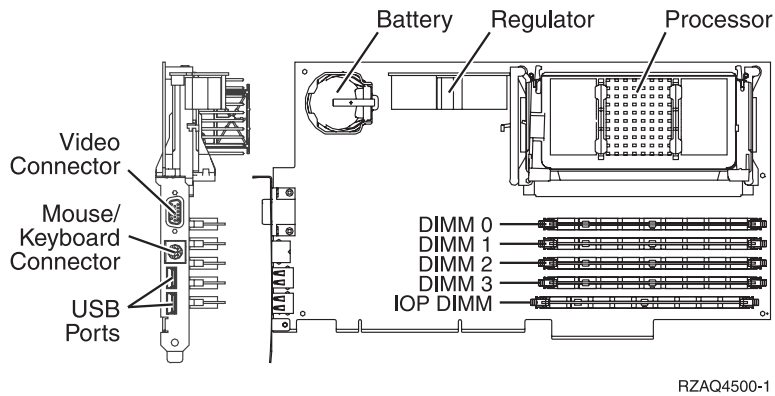
Figure 1. Locations of DIMM 0, DIMM 1, DIMM 2 and DIMM 3 on 2890 Integrated xSeries Server (IXS) card.

Memory for 2890 Integrated xSeries Server (IXS) card: One of the Pentium memory modules (DIMM 0, DIMM 1, DIMM 2, or DIMM 3) may be the failing item. See Type, model, and part number list for part numbers.

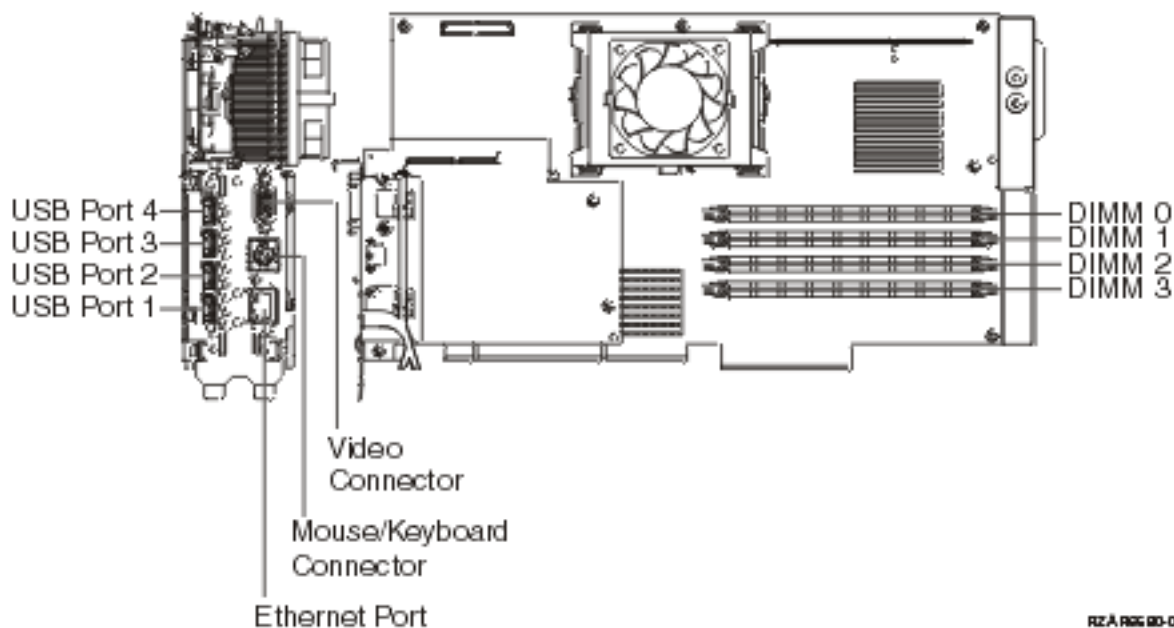
Figure 2. Locations of DIMM 0, DIMM 1, DIMM 2 and DIMM 3 on 2892 Integrated xSeries Server (IXS) card.

Memory for 2892 Integrated xSeries Server (IXS) card: One of the Pentium memory modules (DIMM 0, DIMM 1, DIMM 2, or DIMM 3) may be the failing item. See Type, model, and part number list for part numbers.
