## 7148/7149 – PCI Riser card Insertion Issue

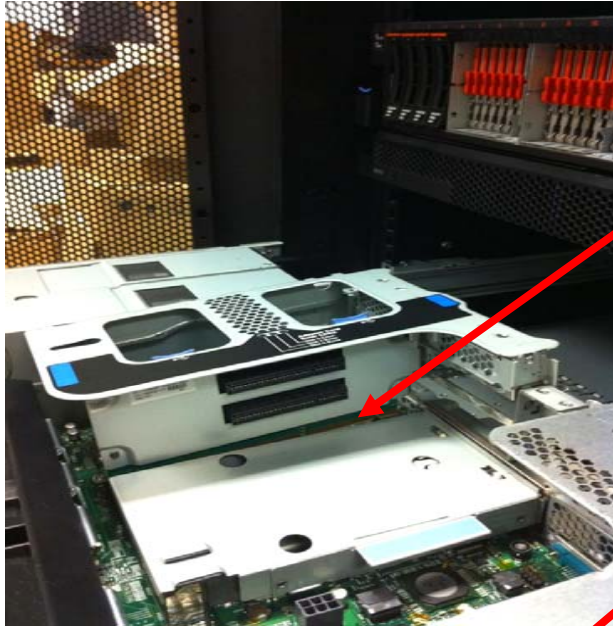
Improper install method. The card should not be installed on an angle.

Note that when installed on an angle the card edge can enter the planar connector several contacts from the end. If the card is then slid back in the connector when installed, the planar connector can be damaged.

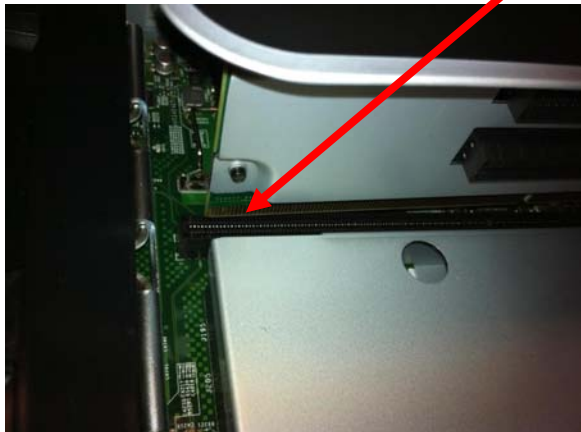
Close up view of potential pin damage.

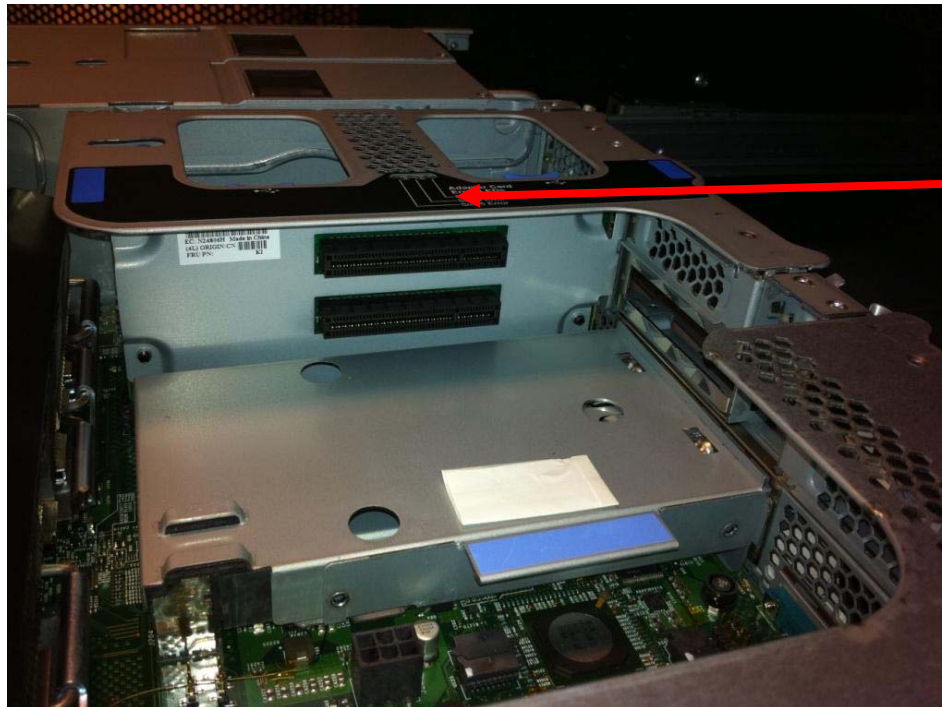
Proper method for installing the card is to hold it flat and push it straight down into the planar connector.
